Known problems, issues, and their solution

GM4000 HPS II

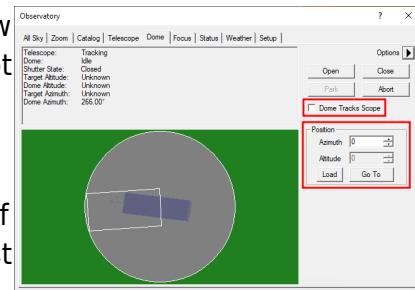
Description of the problem: The dome's wall obscures the view of the telescope to the sky. This happens when the dome does not follow the pointing of the telescope, i.e. the open shutter is not in phase with the telescope.

Solution: The dome control can determine the current position of the dome by means of a magnet. For this purpose, the dome must be moved through the south point once:

1. Disconnect the dome from the telescope. To do this, go to the **Dome tab** in *Maxim DL* in the **Observatory control window** and deactivate the option **Dome Tracks Scope**.
2. Then the dome can be moved around using the dome remote control or in *Maxim DL* in the **Dome tab** of the **Observatory control window** using the options in the Positions section. For the latter, the desired target azimuth (Azimuth) must be selected and then **Go To** clicked.
3. Finally, re-establish the connection between the dome and the telescope.

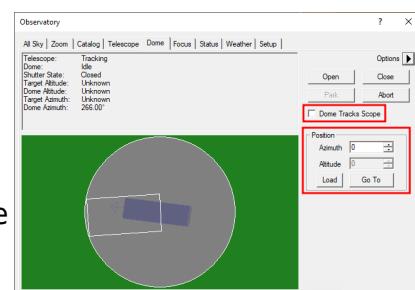
Description of the problem: The motor that drives the dome rotation can be heard but the dome does not rotate.

1. Push in the red emergency switch on the control unit for the dome (see [here](#)).
2. Disconnect the dome from the telescope. To do this, go to the **Dome tab** in *Maxim DL* in the **Observatory control window** and deactivate the option **Dome Tracks Scope**.
3. Pull out the emergency switch again. The dome can now be operated again using the remote control.
4. Now press the azimuth buttons alternately until the dome moves freely again.
5. Finally, re-establish the connection between the dome and the telescope.

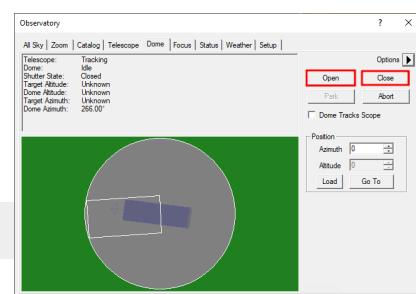
Description of the problem: The shutter or the hatch do not close via the remote control.

Solution 1: On the hand terminal, use the command to close the dome completely:

MENU - Settings - Dome - Close Shutter

. After that, the hatch and shutter should open and close properly again using the remote control.

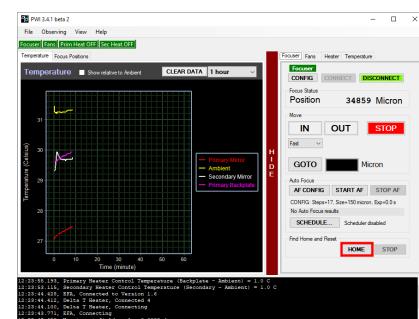
Problem description: PWI3 shows clearly negative position values when driving in or the focuser does not run in the positive range (when driving out) up to the maximum $\sim 35000\mu$.

Solution: The focuser has “swallowed” and the encoder delivers wrong values. This can be fixed by clicking on Home (see picture) in the Focuser tab of PWI3 under Find Home and Reset and then on YES. This will reset the focuser and reinitialize the home position, restoring the normal focus range.

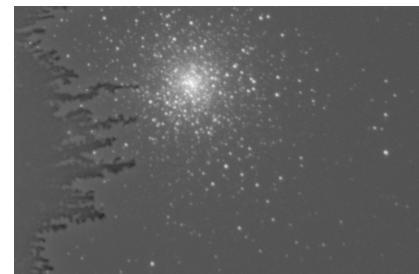
Description of the problem: The CCD chip of the camera has experienced icing, see image on the right.

Solution: The cameras' interior is not in a vacuum and moisture can get in, causing icing on the cooled CCD chip. To prevent this, the cameras have dry cartouches with desiccants. If icing appears, the cartouches need to be regenerated ([see this article](#)). During that observational night, wait for approximately one hour until the ice sublimates from the CCD chip.

Exposure of the cluster M15 with the ST-8. The left side clearly shows icing on the CCD.

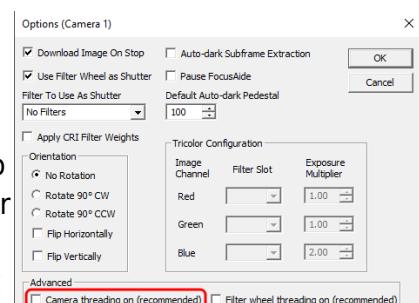
Camera options menu in *Maxim DL*

Description of the problem: When trying to couple two SBIG cameras simultaneously with *Maxim DL*, *Maxim DL* becomes very slow, hangs or crashes.

Solution: This can be due to the fact that Camera threading on (recommended) is set in the camera options. This option must be deactivated for the SBIG cameras. Afterwards the cameras should connect and work as usual.

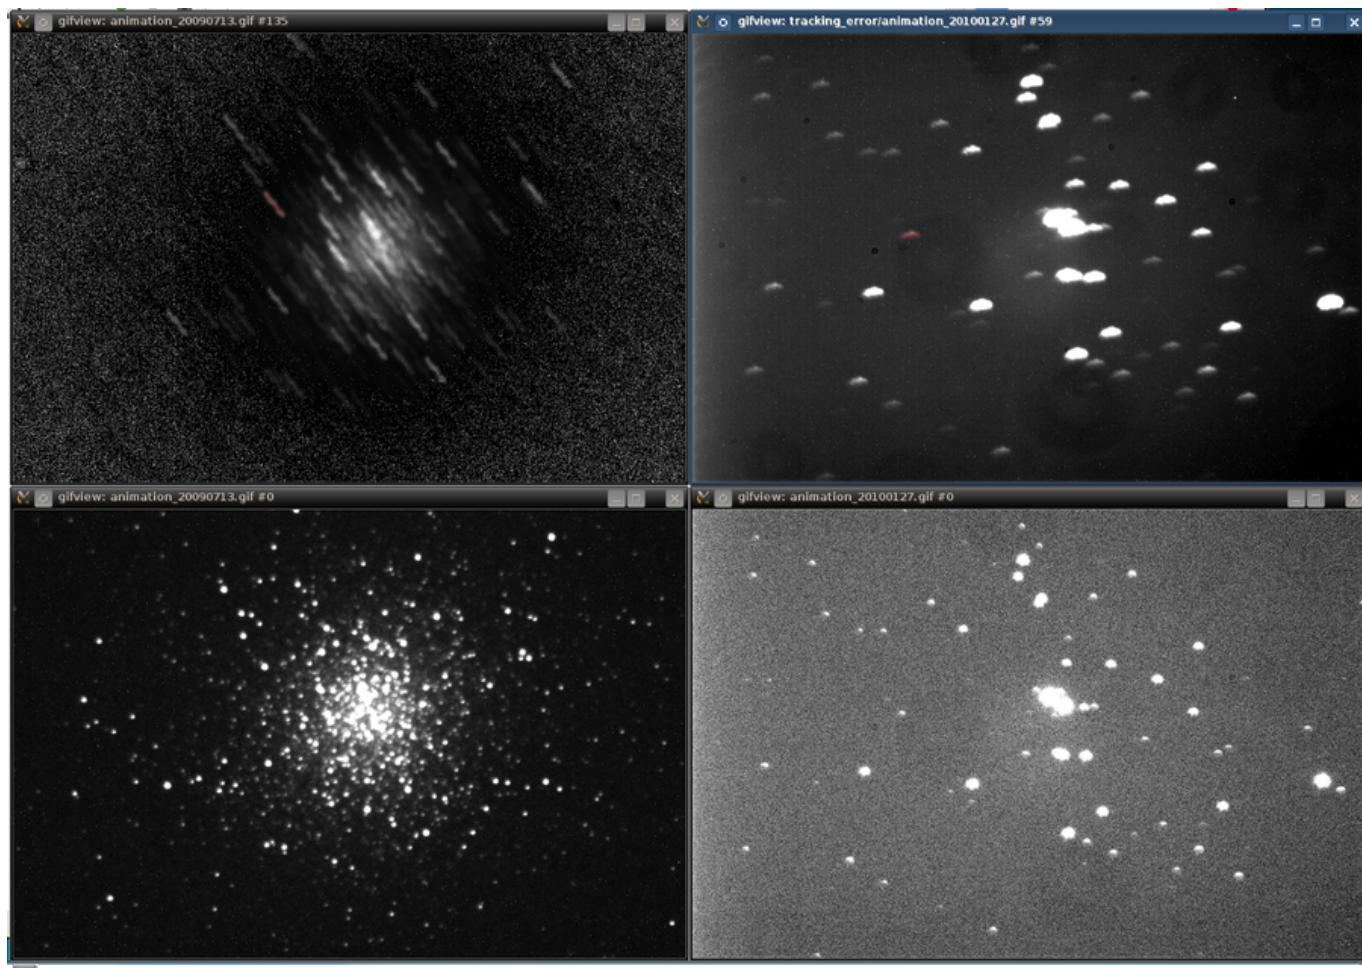
The following image illustrates the telescope's tracking problem. On the left panels, you can see the globular cluster M 13. The lower left panel shows an exposure of 10s, which gives a fair result. The upper left panel combines 135 exposures of each 10s, so approx. 35 minutes in total. The stars are clearly smeared and describe a fine zig-zag line (length of about 1/2').

The right panels show the exposures of an open cluster of 30s exposure time. Again, the lower right panel shows one exposure, the upper right the combinations of all following exposures.

Tracking errors of a globular cluster (M 13, left panels) and an open cluster (right panels)
