Known problems, issues, and their solution

GM4000 HPS II

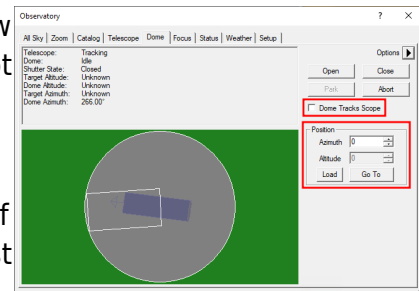
Dome wall vs. telescope I

Description of the problem: The dome's wall obscures the view of the telescope to the sky. This happens when the dome does not follow the pointing of the telescope, i.e. the open shutter is not in phase with the telescope.

Solution: The dome control can determine the current position of the dome by means of a magnet. For this purpose, the dome must be moved through the south point once:

1. Disconnect the dome from the telescope. To do this, go to the **Dome tab** in *Maxim DL* in the **Observatory control window** and deactivate the option Dome Tracks Scope.
2. Then the dome can be moved around using the dome remote control or in *Maxim DL* in the **Dome tab** of the **Observatory control window** using the options in the Positions section. For the latter, the desired target azimuth (Azimuth) must be selected and then Go To clicked.
3. Finally, re-establish the connection between the dome and the telescope.

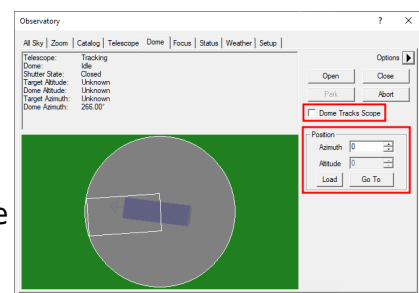
Dome wall vs. telescope II

Description of the problem: The motor that drives the dome rotation can be heard but the dome does not rotate.

1. Push in the red emergency switch on the control unit for the dome (see [here](#)).
2. Disconnect the dome from the telescope. To do this, go to the **Dome tab** in *Maxim DL* in the **Observatory control window** and deactivate the option Dome Tracks Scope.
3. Pull out the emergency switch again. The dome can now be operated again using the remote control.
4. Now press the azimuth buttons alternately until the dome moves freely again.
5. Finally, re-establish the connection between the dome and the telescope.

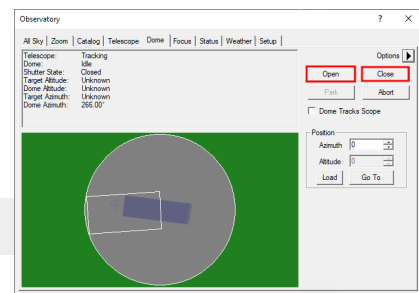
Shutter vs. hatch II

Description of the problem: The shutter or the hatch do not close via the remote control.

Solution 1: On the hand terminal, use the command to close the dome completely:

MENU - Settings - Dome - Close Shutter

. After that, the hatch and shutter should open and close properly again using the remote control.

Solution 2: In *Maxim DL* in the **Observatory control window** go to the **Dome-Tab** and try to open the dome again with Open. Afterwards close it with Close.

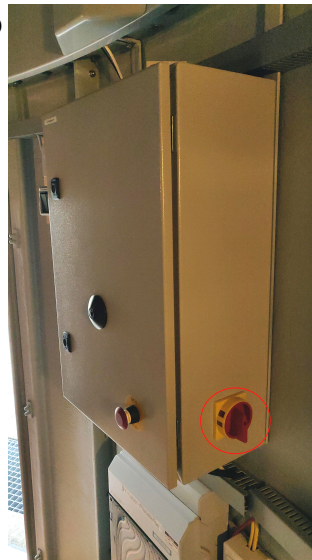
Fig. 1: Dome control box - red: main switch

Shutter and/or hatch cannot be moved at all

Problem description: The shutter and/or hatch can no longer be moved even with the methods described above, because a component may have broken.

1. Switch off controls and power supply
 - Turn the **main switch** on the right

side of the gray dome control box to **OFF** (Fig. 1)

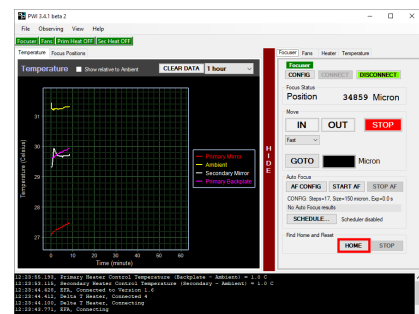
Focuser of the CDK20 does not run the complete range of $\sim 35000\mu$

Problem description: PWI3 shows clearly negative position values when driving in or the focuser does not run in the positive range (when driving out) up to the maximum $\sim 35000\mu$.

Solution: The focuser has “swallowed” and the encoder delivers wrong values. This can be fixed by clicking on Home (see picture) in the Focuser tab of PWI3 under Find Home and Reset and then on YES. This will reset the focuser and reinitialize the home position, restoring the normal focus range.

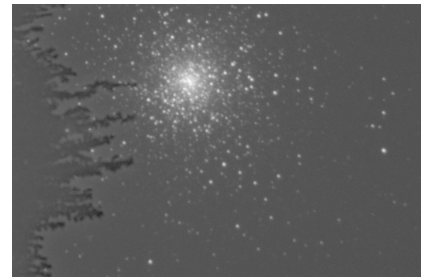
Description of the problem: The CCD chip of the camera has experienced icing, see image on the right.

Exposure of the cluster M15 with the ST-8. The left side clearly shows icing on the CCD.

Solution: The cameras' interior is not in a vacuum and moisture can get in, causing icing on the cooled CCD chip. To prevent this, the cameras have dry cartouches with desiccants. If icing appears, the cartouches need to be regenerated ([see this article](#)). During that observational night, wait for approximately one hour until the ice sublimates from the CCD chip.

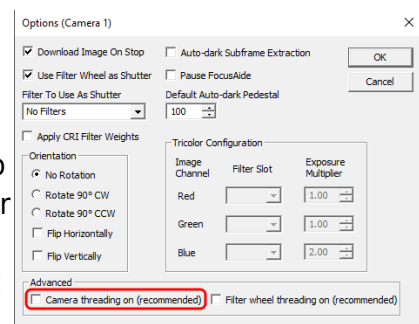
Camera options menu in *Maxim DL*

Description of the problem: When trying to couple two SBIG cameras simultaneously with *Maxim DL*, *Maxim DL* becomes very slow, hangs or crashes.

Solution: This can be due to the fact that Camera threading on (recommended) is set in the camera options. This option must be deactivated for the SBIG cameras. Afterwards the cameras should connect and work as usual.
