Known problems, issues, and their solution

GM4000 HPS II

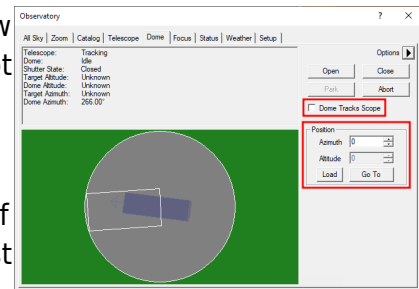
Dome wall vs. telescope I

Description of the problem: The dome's wall obscures the view of the telescope to the sky. This happens when the dome does not follow the pointing of the telescope, i.e. the open shutter is not in phase with the telescope.

Solution: The dome control can determine the current position of the dome by means of a magnet. For this purpose, the dome must be moved through the south point once:

1. Disconnect the dome from the telescope. To do this, go to the **Dome tab** in *Maxim DL* in the **Observatory control window** and deactivate the option **Dome Tracks Scope**.
2. Then the dome can be moved around using the dome remote control or in *Maxim DL* in the **Dome tab** of the **Observatory control window** using the options in the **Positions** section. For the latter, the desired target azimuth (**Azimuth**) must be selected and then **Go To** clicked.
3. Finally, re-establish the connection between the dome and the telescope.

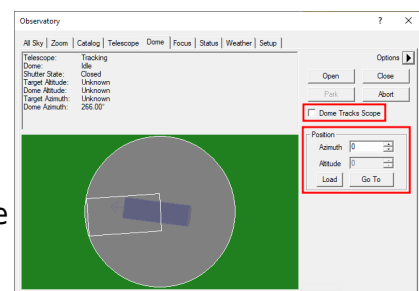
Dome wall vs. telescope II

Description of the problem: The motor that drives the dome rotation can be heard but the dome does not rotate.

1. Push in the red emergency switch on the control unit for the dome (see [here](#)).
2. Disconnect the dome from the telescope. To do this, go to the **Dome tab** in *Maxim DL* in the **Observatory control window** and deactivate the option **Dome Tracks Scope**.
3. Pull out the emergency switch again. The dome can now be operated again using the remote control.
4. Now press the azimuth buttons alternately until the dome moves freely again.
5. Finally, re-establish the connection between the dome and the telescope.

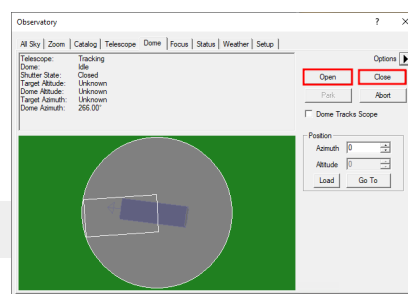
Shutter vs. hatch II

Description of the problem: The shutter or the hatch do not close via the remote control.

Solution 1: On the hand terminal, use the command to close the dome completely:

```
MENU - Settings - Dome - Close Shutter
```

. After that, the hatch and shutter should open and close properly again using the remote control.

Solution 2: In *Maxim DL* in the **Observatory control window** go to the **Dome-Tab** and try to open the dome again with Open. Afterwards close it with Close.

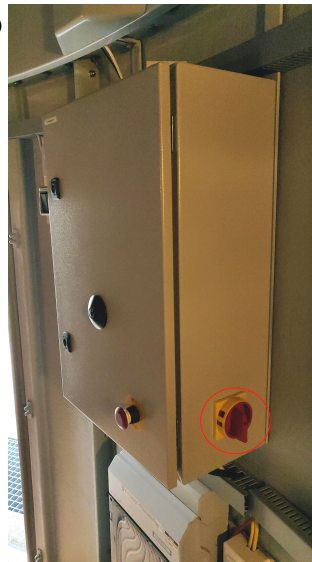
Fig. 1: Dome control box - red: main switch

Shutter and/or hatch cannot be moved at all

Problem description: The shutter and/or hatch can no longer be moved even with the methods described above, because a component may have broken.

1. Switch off controls and power supply
 - Turn the **main switch** on the right

side of the gray dome control box **to OFF** (Fig. 1)

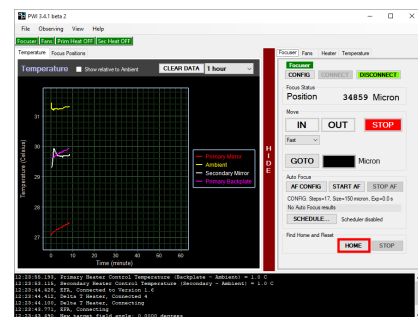
Focuser of the CDK20 does not run the complete range of ~35000μ

Problem description: PWI3 shows clearly negative position values when driving in or the focuser does not run in the positive range (when driving out) up to the maximum ~35000μ.

Solution: The focuser has “swallowed” and the encoder delivers wrong values. This can be fixed by clicking on Home (see picture) in the Focuser tab of PWI3 under Find Home and Reset and then on YES. This will reset the focuser and reinitialize the home position, restoring the normal focus range.

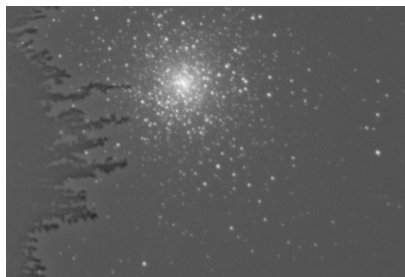
Description of the problem: The CCD chip of the camera has experienced icing, see image on the right.

Exposure of the cluster M15 with the ST-8. The left side clearly shows icing on the CCD.

Solution: The cameras' interior is not in a vacuum and moisture can get in, causing icing on the cooled CCD chip. To prevent this, the cameras have dry cartouches with desiccants. If icing appears, the cartouches need to be regenerated ([see this article](#)). During that observational night, wait for approximately one hour until the ice sublimates from the CCD chip.

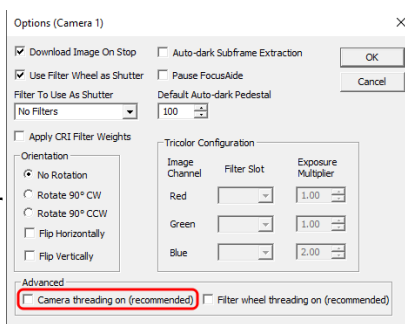
Camera options menu in *Maxim DL*

Maxim DL: Two SBIG cameras cannot be simultaneously connected

Description of the problem: When trying to couple two SBIG cameras simultaneously with *Maxim DL*, *Maxim DL* becomes very slow, hangs or crashes.

Solution: This can be due to the fact that `Camera threading on (recommended)` is set in the camera options. This option must be deactivated for the SBIG cameras. Afterwards the cameras should connect and work as usual.

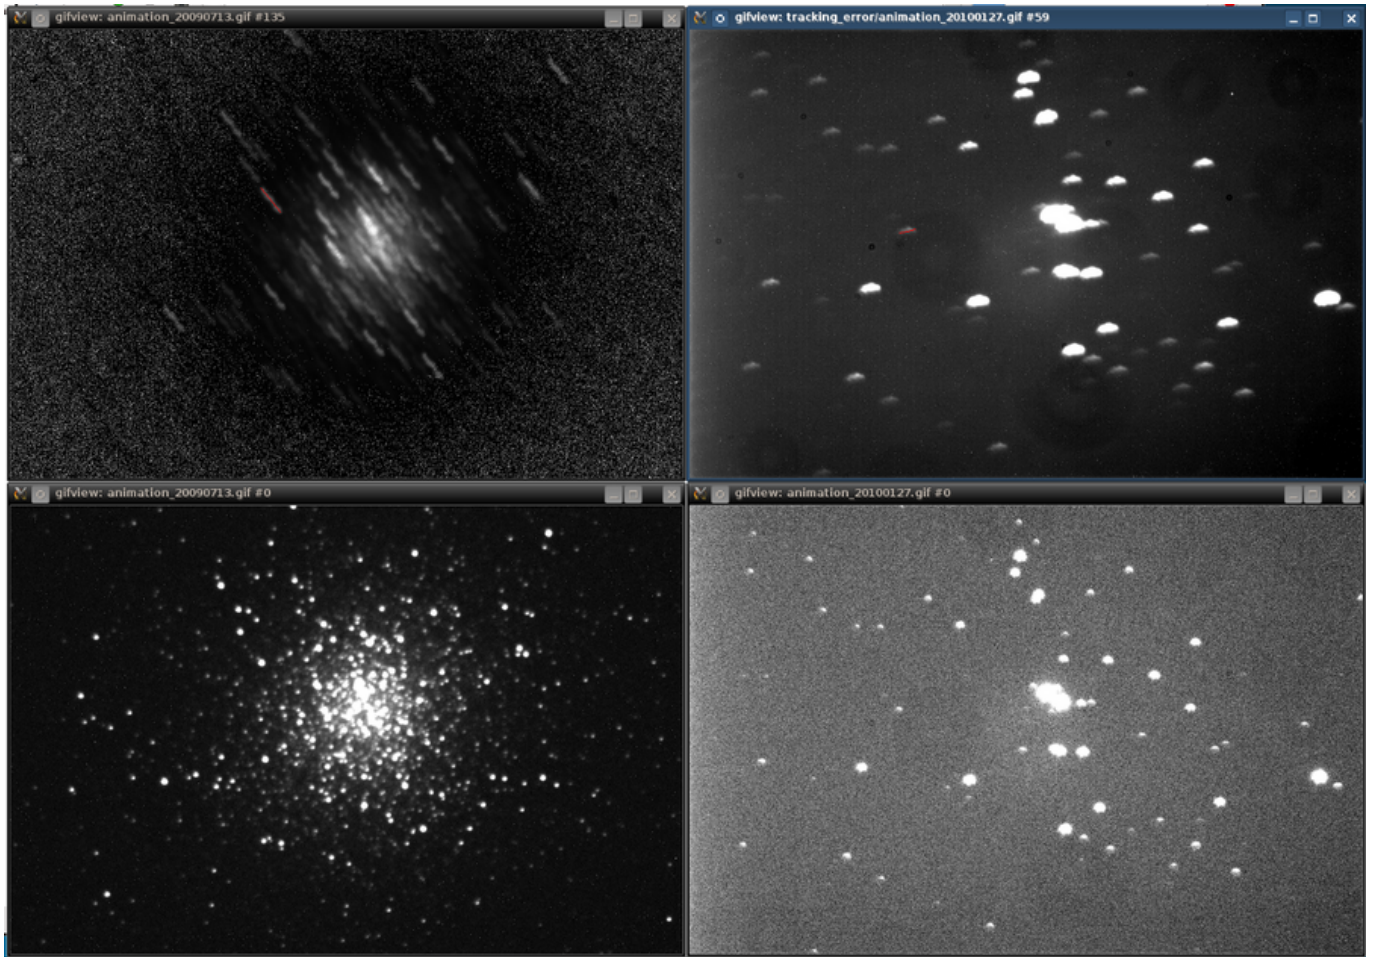
The following image illustrates the telescope's tracking problem. On the left panels, you can see the globular cluster M 13. The lower left panel shows an exposure of 10s, which gives a fair result. The upper left panel combines 135 exposures of each 10s, so approx. 35 minutes in total. The stars are clearly smeared and describe a fine zig-zag line (length of about 1/2').

The right panels show the exposures of an open cluster of 30s exposure time. Again, the lower right panel shows one exposure, the upper right the combinations of all following exposures.

Tracking errors of a globular cluster (M 13, left panels) and an open cluster (right panels)
