Known problems, issues, and their solution

<https://polaris.astro.physik.uni-potsdam.de/wiki/> - **OST Wiki**

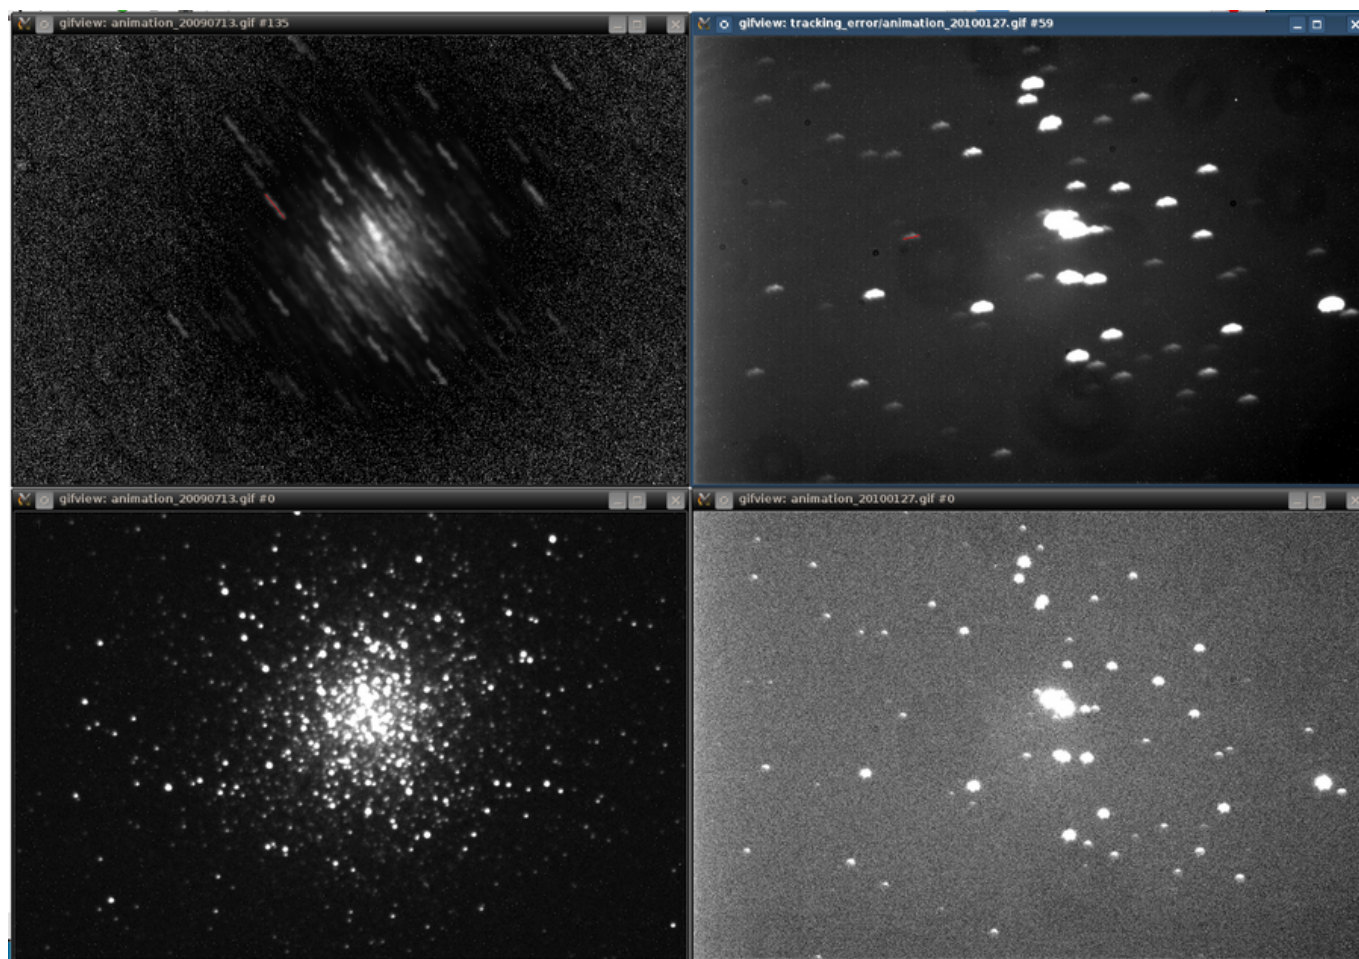
The following image illustrates the telescope's tracking problem. On the left panels, you can see the globular cluster M 13. The lower left panel shows an exposure of 10s, which gives a fair result. The upper left panel combines 135 exposures of each 10s, so approx. 35 minutes in total. The stars are

clearly smeared and describe a fine zig-zag line (length of about $1/2'$).

The right panels show the exposures of an open cluster of 30s exposure time. Again, the lower right panel shows one exposure, the upper right the combinations of all following exposures.

Note: The exposures were taken with the ST-8 and are not fully reduced here.

Tracking errors of a globular cluster (M 13, left panels) and an open cluster (right panels)
