# Known problems, issues, and their solution

<https://polaris.astro.physik.uni-potsdam.de/wiki/> - **OST Wiki**

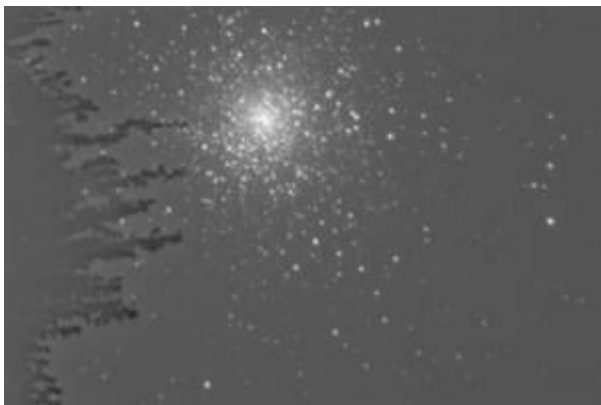
Exposure of the cluster M15 with the ST-8. The left side clearly shows icing on the CCD.

**Description of the problem:** The CCD chip of the camera has experienced icing, see image on the right.

**Solution:** The cameras' interior is not in a vacuum and moisture can get in, causing icing on the cooled CCD chip. To prevent this, the cameras have dry cartouches with desiccants. If icing appears, the cartouches need to be regenerated ([see this article](#)). During that observational night, wait for approximately one hour until the ice sublimates from the CCD chip.

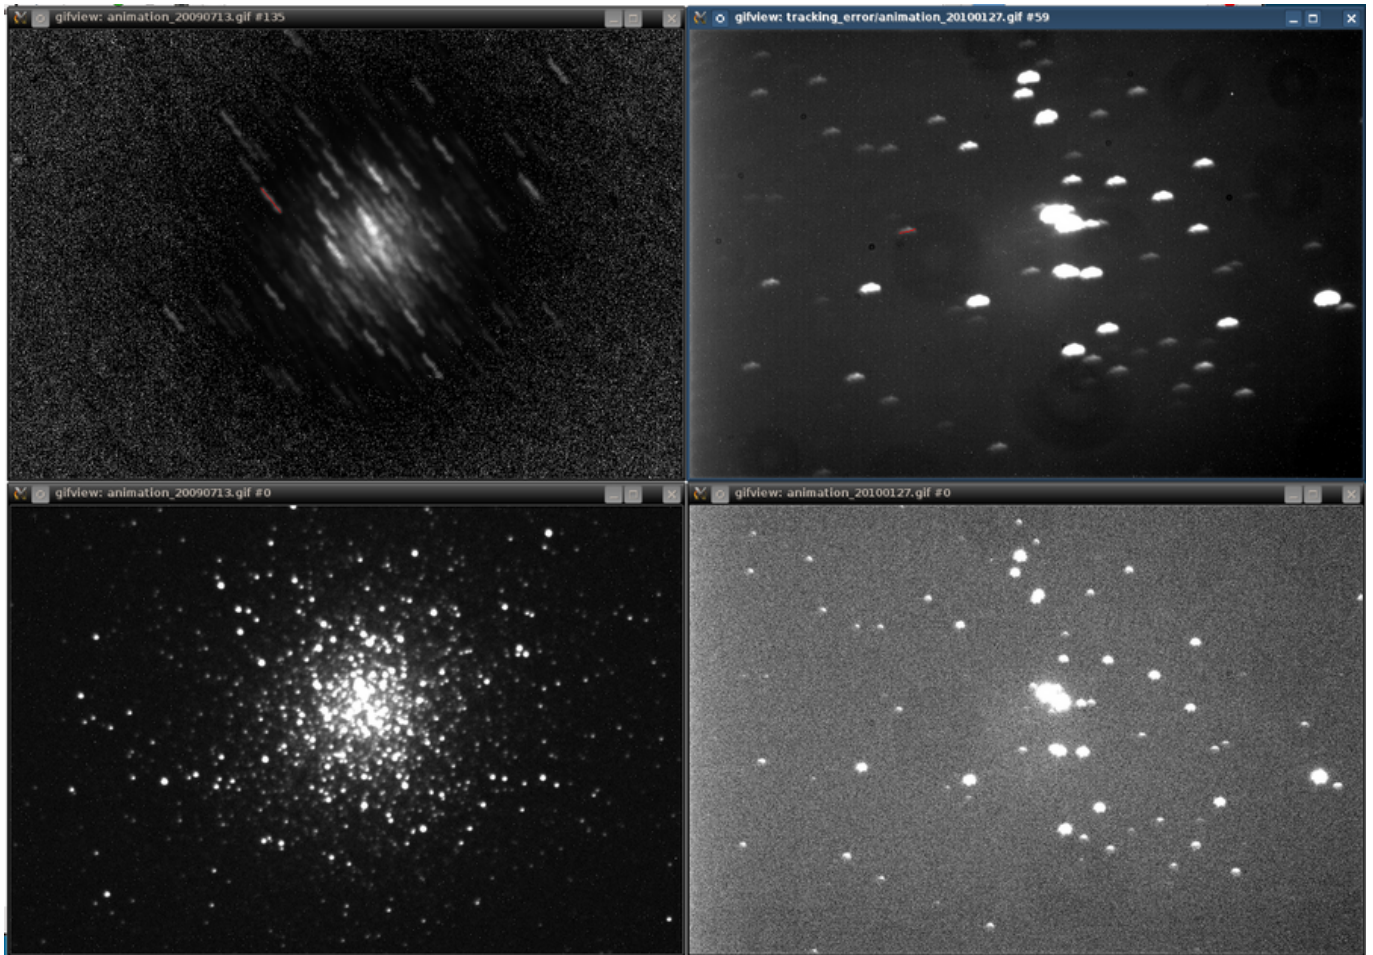
The following image illustrates the telescope's tracking problem. On the left panels, you can see the globular cluster M 13. The lower left panel shows an exposure of 10s, which gives a fair result. The upper left panel combines 135 exposures of each 10s, so approx. 35 minutes in total. The stars are

clearly smeared and describe a fine zig-zag line (length of about 1/2').

The right panels show the exposures of an open cluster of 30s exposure time. Again, the lower right panel shows one exposure, the upper right the combinations of all following exposures.

Tracking errors of a globular cluster (M 13, left panels) and an open cluster (right panels)
