Known problems, issues, and their solution

<https://polaris.astro.physik.uni-potsdam.de/wiki/> - **OST Wiki**

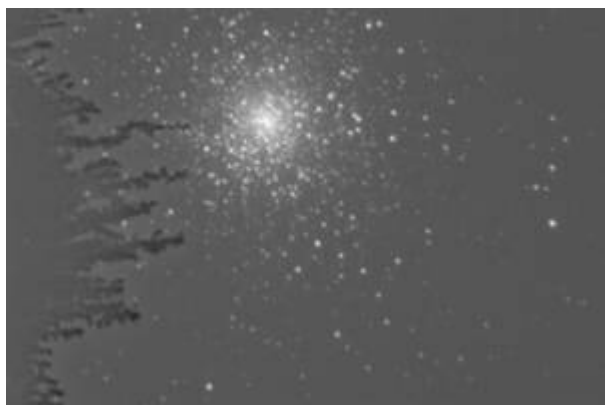
Exposure of the cluster M15 with the ST-8. The left side clearly shows icing on the CCD.

Description of the problem: The CCD chip of the camera has experienced icing, see image on the right.

Solution: The cameras' interior is not in a vacuum and moisture can get in, causing icing on the cooled CCD chip. To prevent this, the cameras have dry cartouches with desiccants. If icing appears, the cartouches need to be regenerated ([see this article](#)). During that observational night, wait for approximately one hour until the ice sublimates from the CCD chip.
