Known problems, issues, and their solution

From: https://polaris.astro.physik.uni-potsdam.de/wiki/ - OST Wiki

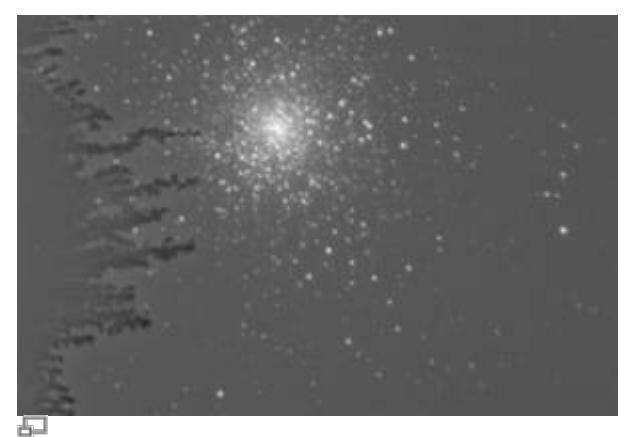
Exposure of the cluster M15 with the ST-8. The left side clearly shows icing on the CCD.

Description of the problem: The CCD chip of the camera has experienced icing, see image on the right.

Solution: The cameras' interior is not in a vacuum and moisture can get in, causing icing on the cooled CCD chip. To prevent this, the cameras have dry cartouches with desiccants. If icing appears, the cartouches need to be regenerated (see this article). During that observational night, wait for approximately one hour until the ice sublimates from the CCD chip.

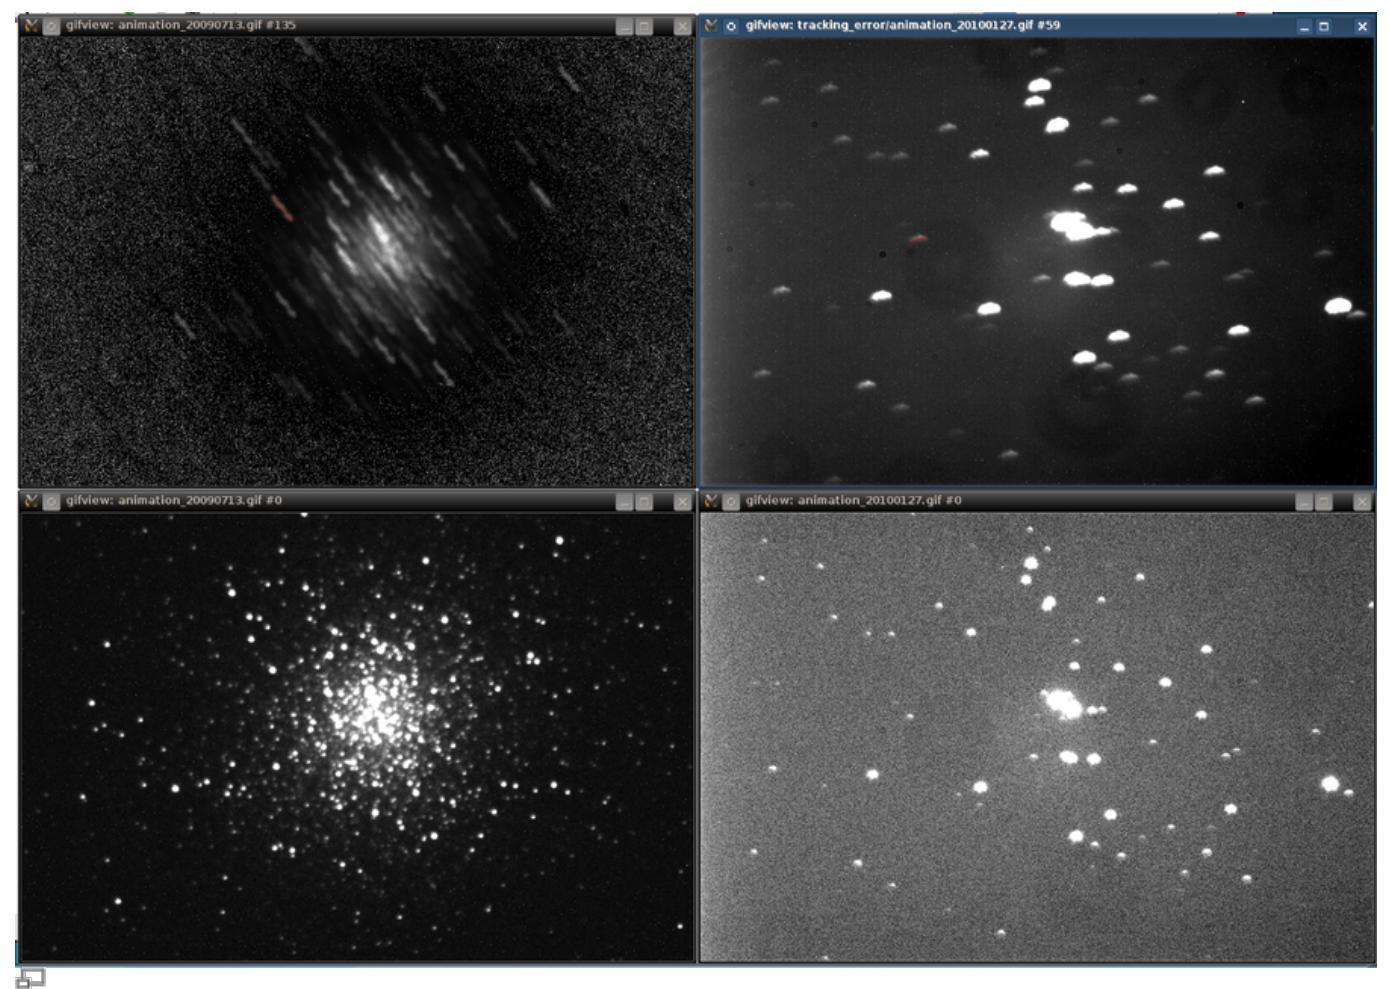
The following image illustrates the telescope's tracking problem. On the left panels, you can see the globular cluster M 13. The lower left panel shows an exposure of 10s, which gives a fair result. The upper left panel combines 135 exposures of each 10s, so approx. 35 minutes in total. The stars are clearly smeared and describe a fine zig-zag line (length of about 1/2').

The right panels show the exposures of an open cluster of 30s exposure time. Again, the lower right panel shows one exposure, the upper right the combinations of all following exposures.

Tracking errors of a globular cluster (M 13, left panels) and an open cluster (right panels) Invalid Link
