Known problems, issues, and their solution

<https://polaris.astro.physik.uni-potsdam.de/wiki/> - **OST Wiki**

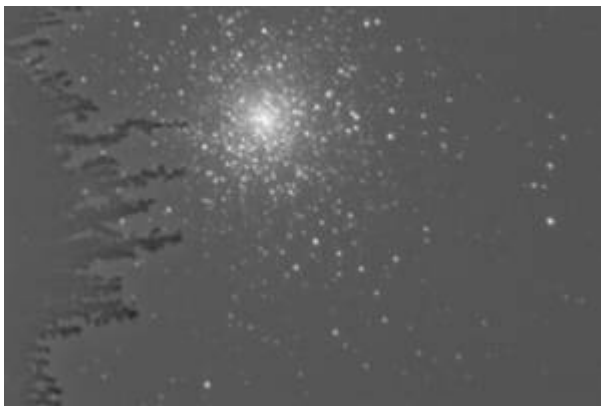
Ice on the camera

Exposure of the cluster M15 with the ST-8. The left side clearly shows icing on the CCD.

Description of the problem: The CCD chip of the camera has experienced icing, see image on the right.

Solution: The cameras' interior is not in a vacuum and moisture can get in, causing icing on the cooled CCD chip. To prevent this, the cameras have dry cartouches with desiccants. If icing appears, the cartouches need to be regenerated ([see this article](#)). During that observational night, wait for approximately one hour until the ice sublimates from the CCD chip.

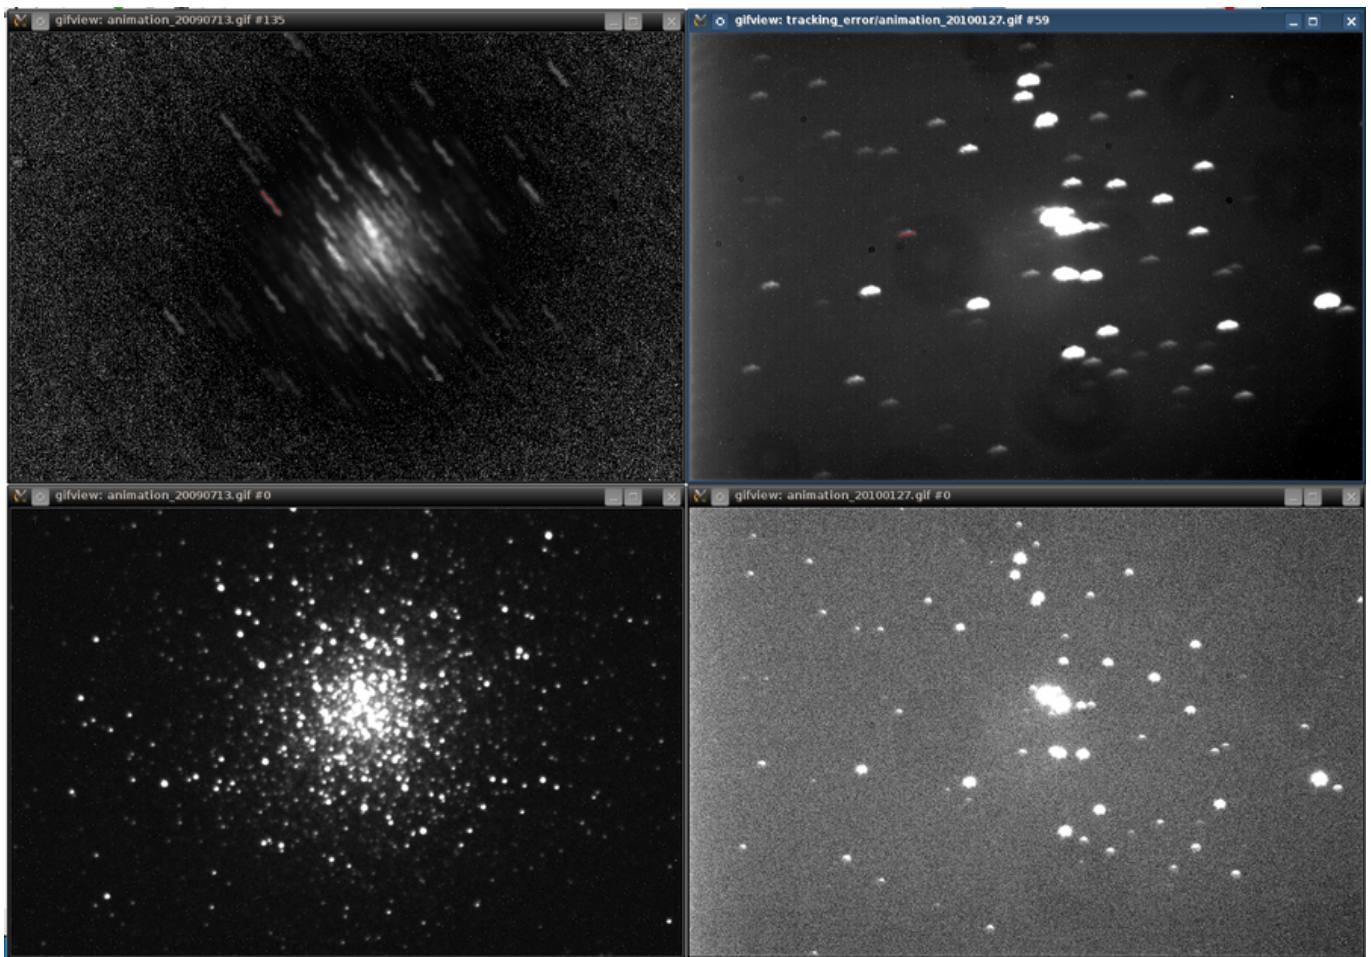
Tracking error

The following image illustrates the telescope's tracking problem. On the left panels, you can see the globular cluster M 13. The lower left panel shows an exposure of 10s, which gives a fair result. The upper left panel combines 135 exposures of each 10s, so approx. 35 minutes in total. The stars are clearly smeared and describe a fine zig-zag line (length of about 1/2').

The right panels show the exposures of an open cluster of 30s exposure time. Again, the lower right panel shows one exposure, the upper right the combinations of all following exposures.

Tracking errors of a globular cluster (M 13, left panels) and an open cluster (right panels)
