Known problems, issues, and their solution

<https://polaris.astro.physik.uni-potsdam.de/wiki/> - **OST Wiki**

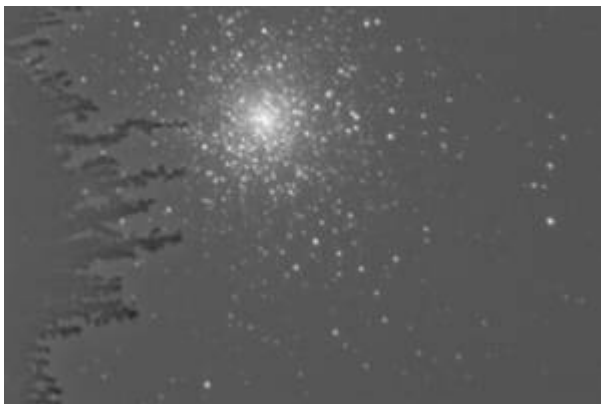
Ice on the camera

Exposure of the cluster M15 with the ST-8. The left side clearly shows icing on the CCD.

Description of the problem: The CCD chip of the camera has experienced icing, see image on the right.

Solution: The cameras' interior is not in a vacuum and moisture can get in, causing icing on the cooled CCD chip. To prevent this, the cameras have dry cartouches with desiccants. If icing appears, the cartouches need to be regenerated ([see this article](#)). During that observational night, wait for approximately one hour until the ice sublimates from the CCD chip.

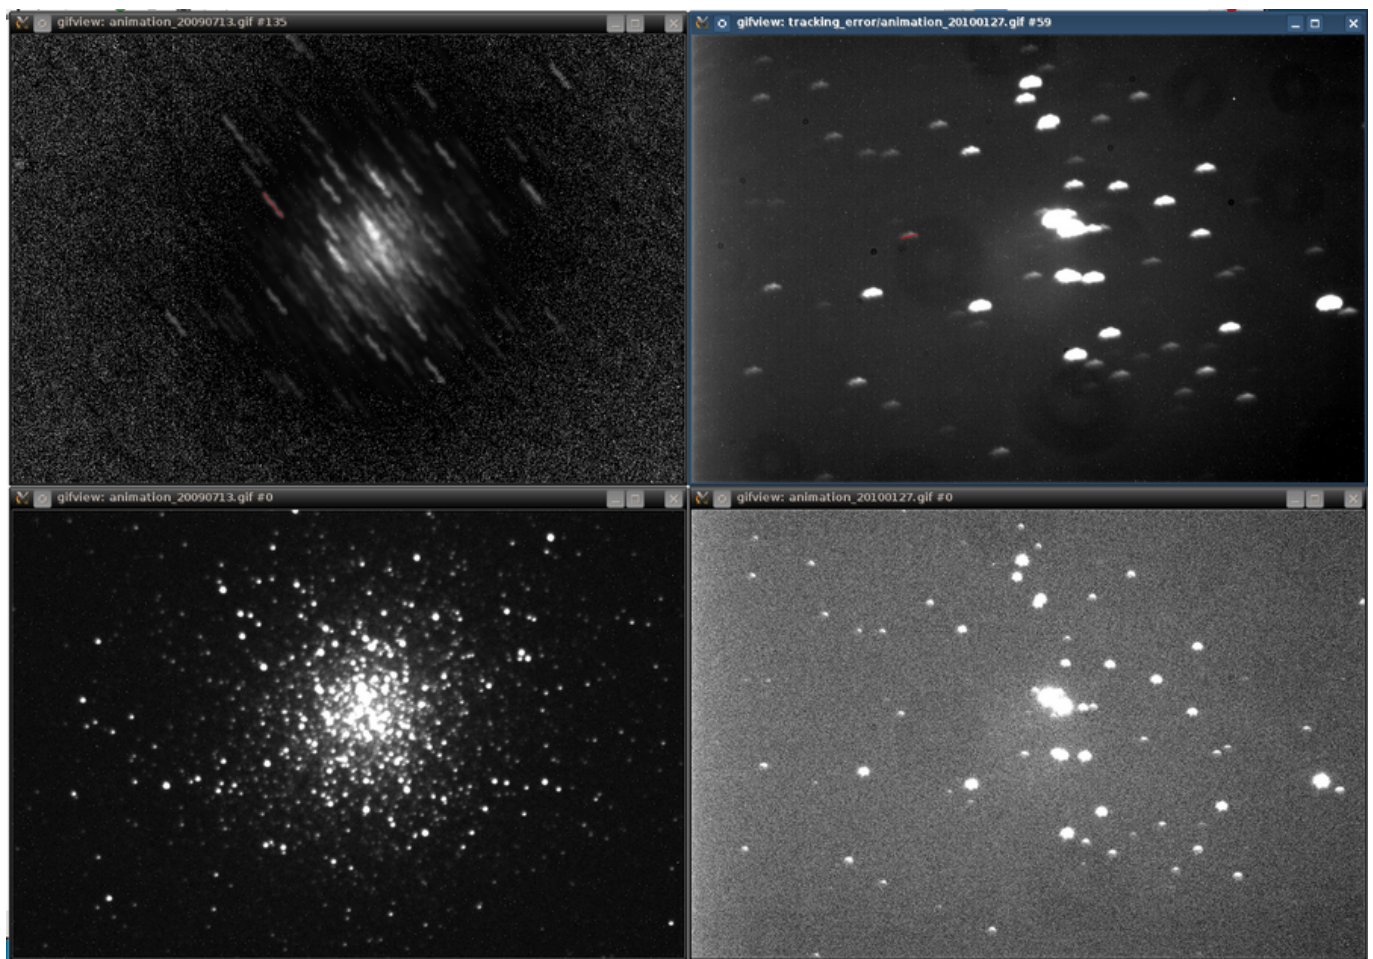
Tracking error

The following image illustrates the telescope's tracking problem. On the left panels, you can see the globular cluster M 13. The lower left panel shows an exposure of 10s, which gives a fair result. The upper left panel combines 135 exposures of each 10s, so approx. 35 minutes in total. The stars are clearly smeared and describe a fine zig-zag line (length of about $1/2'$).

The right panels show the exposures of an open cluster of 30s exposure time. Again, the lower right panel shows one exposure, the upper right the combinations of all following exposures.

Note: The exposures were taken with the ST-8 and are not fully reduced here.

Tracking errors of a globular cluster (M 13, left panels) and an open cluster (right panels)
