Known problems, issues, and their solution

Last update: 2019/07/24 en:ost:telescope:probleme https://polaris.astro.physik.uni-potsdam.de/wiki/doku.php?id=en:ost:telescope:probleme&rev=1563967156 11:19

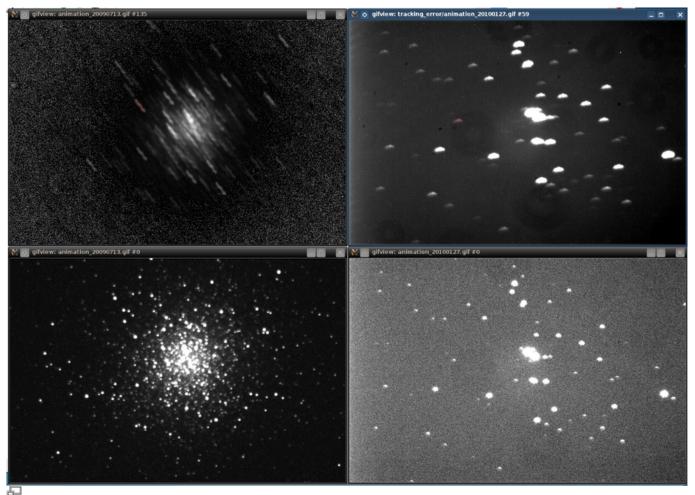
The following image illustrates the telescope's tracking problem. On the left panels, you can see the globular cluster M 13. The lower left panel shows an exposure of 10s, which gives a fair result. The upper left panel combines 135 exposures of each 10s, so approx. 35 minutes in total. The stars are clearly smeared and describe a fine zig-zag line (length of about 1/2').

The right panels show the exposures of an open cluster of 30s exposure time. Again, the lower right panel shows one exposure, the upper right the combinations of all following exposures.

Note: The exposures were taken with the ST-8 and are not fully reduced here.

Tracking errors of a globular cluster (M 13, left panels) and an open cluster (right panels) Invalid Link
