Known problems, issues, and their solution

From: <https://polaris.astro.physik.uni-potsdam.de/wiki/> - OST Wiki

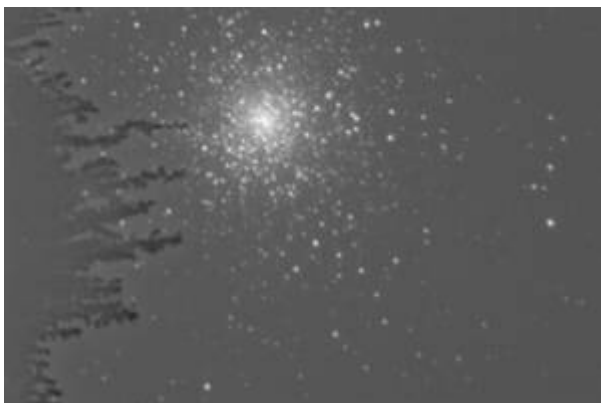
Ice on the camera

Exposure of the cluster M15 with the ST-8. The left side clearly shows icing on the CCD.

Description of the problem: The CCD chip of the camera has experienced icing, see image on the right.

Solution: The cameras' interior is not in a vacuum and moisture can get in, causing icing on the cooled CCD chip. To prevent this, the cameras have dry cartouches with desiccants. If icing appears, the cartouches need to be regenerated ([see this article](#)). During that observational night, wait for approximately one hour until the ice sublimates from the CCD chip.

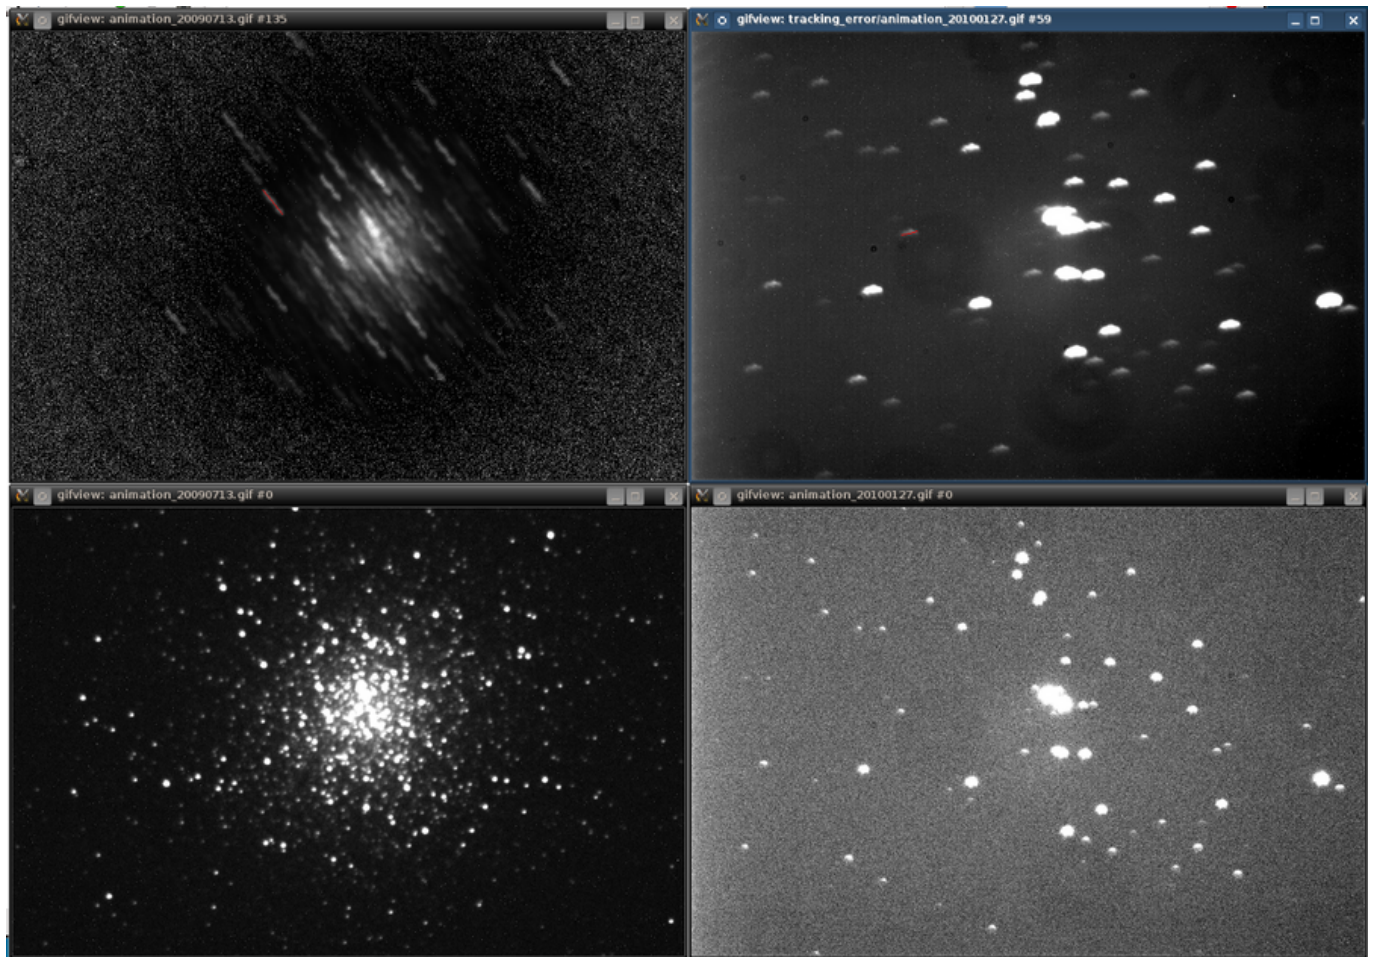
Tracking error

The following image illustrates the telescope's tracking problem. On the left panels, you can see the globular cluster M 13. The lower left panel shows an exposure of 10s, which gives a fair result. The upper left panel combines 135 exposures of each 10s, so approx. 35 minutes in total. The stars are clearly smeared and describe a fine zig-zag line (length of about 1/2').

The right panels show the exposures of an open cluster of 30s exposure time. Again, the lower right panel shows one exposure, the upper right the combinations of all following exposures.

Tracking errors of a globular cluster (M 13, left panels) and an open cluster (right panels)
