Known problems, issues, and their solution

CDK20 and the GM 4000 mount:

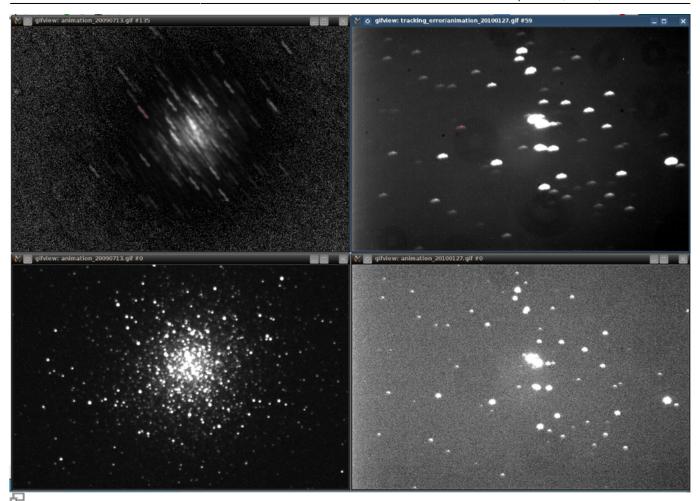
The following image illustrates the telescope's tracking problem. On the left panels, you can see the globular cluster M 13. The lower left panel shows an exposure of 10s, which gives a fair result. The upper left panel combines 135 exposures of each 10s, so approx. 35 minutes in total. The stars are clearly smeared and describe a fine zig-zag line (length of about 1/2').

The right panels show the exposures of an open cluster of 30s exposure time. Again, the lower right panel shows one exposure, the upper right the combinations of all following exposures.

Note: The exposures were taken with the ST-8 and are not fully reduced here.

Tracking errors of a globular cluster (M 13, left panels) and an open cluster (right panels) Invalid Link
