# Known problems, issues, and their solution

<https://polaris.astro.physik.uni-potsdam.de/wiki/> - OST Wiki

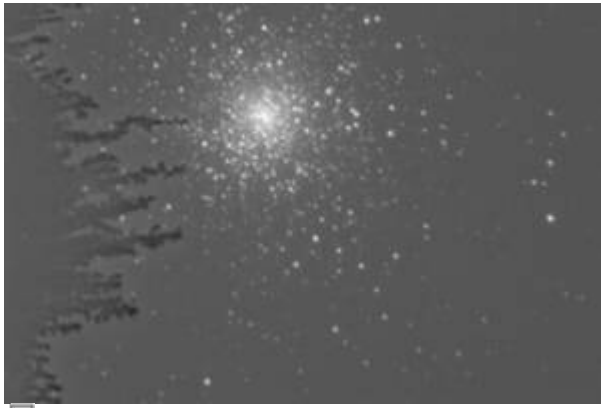
Exposure of the cluster M15 with the ST-8. The left side clearly shows icing on the CCD.

**Description of the problem:** The CCD chip of the camera has experienced icing, see image on the right.

**Solution:** The cameras' interior is not in a vacuum and moisture can get in, causing icing on the cooled CCD chip. To prevent this, the cameras have dry cartouches with desiccants. If icing appears, the cartouches need to be regenerated ([see this article](#)). During that observational night, wait for approximately one hour until the ice sublimates from the CCD chip.

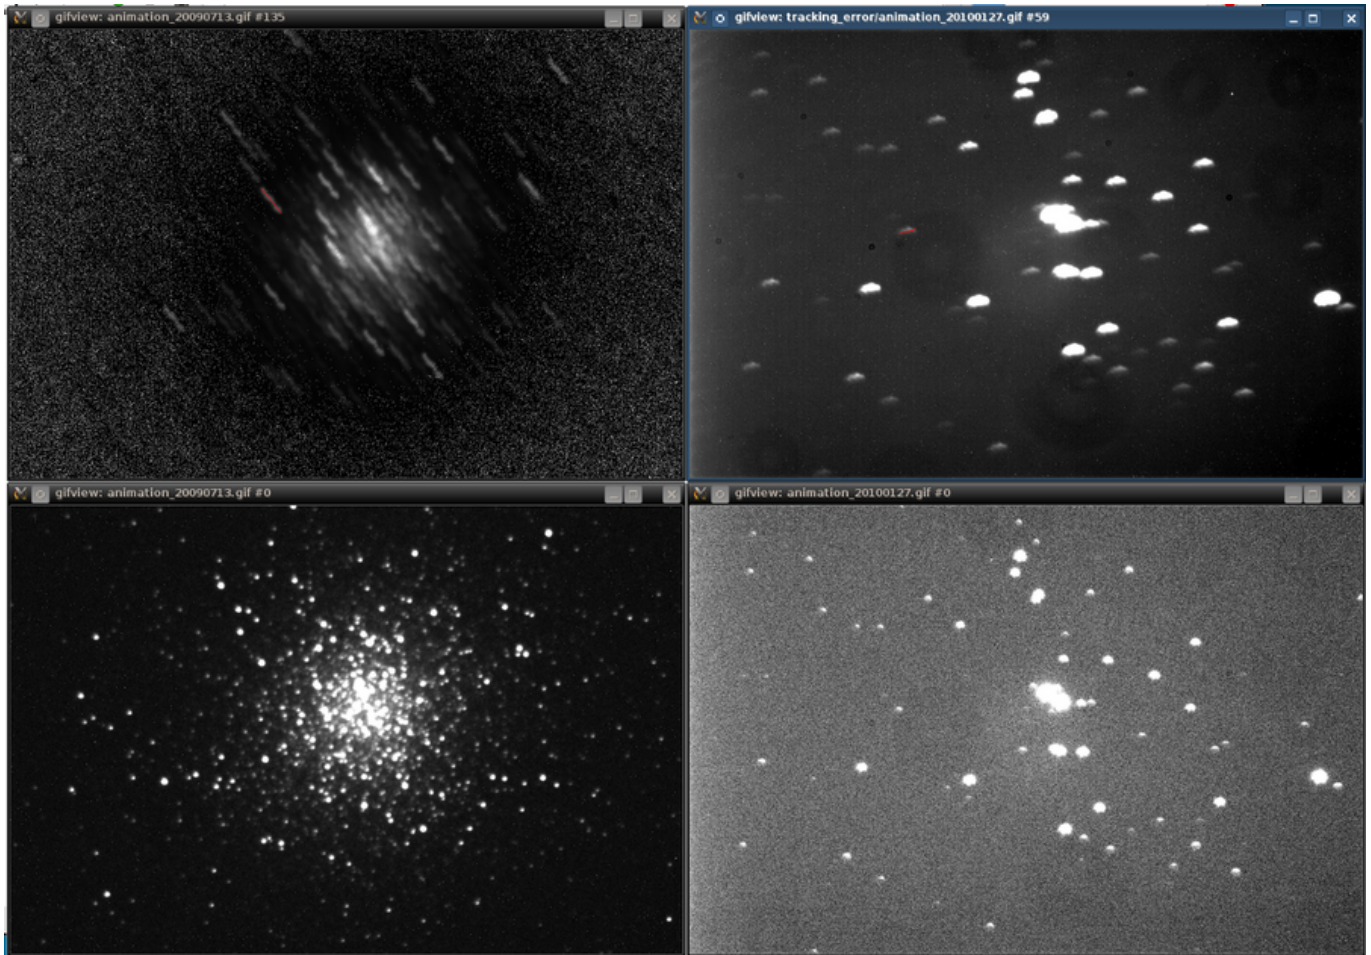
The following image illustrates the telescope's tracking problem. On the left panels, you can see the globular cluster M 13. The lower left panel shows an exposure of 10s, which gives a fair result. The upper left panel combines 135 exposures of each 10s, so approx. 35 minutes in total. The stars are clearly smeared and describe a fine zig-zag line (length of about 1/2').

The right panels show the exposures of an open cluster of 30s exposure time. Again, the lower right panel shows one exposure, the upper right the combinations of all following exposures.

Tracking errors of a globular cluster (M 13, left panels) and an open cluster (right panels)
