Known problems, issues, and their solution

<https://polaris.astro.physik.uni-potsdam.de/wiki/> - OST Wiki

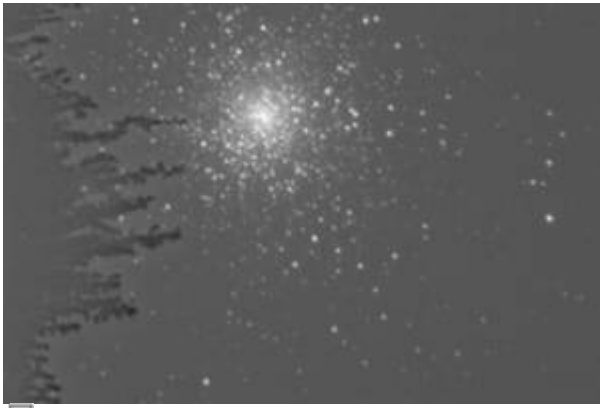
Exposure of the cluster M15 with the ST-8. The left side clearly shows icing on the CCD.

Description of the problem: The CCD chip of the camera has experienced icing, see image on the right.

Solution: The cameras' interior is not in a vacuum and moisture can get in, causing icing on the cooled CCD chip. To prevent this, the cameras have dry cartouches with desiccants. If icing appears, the cartouches need to be regenerated ([see this article](#)). During that observational night, wait for approximately one hour until the ice sublimates from the CCD chip.

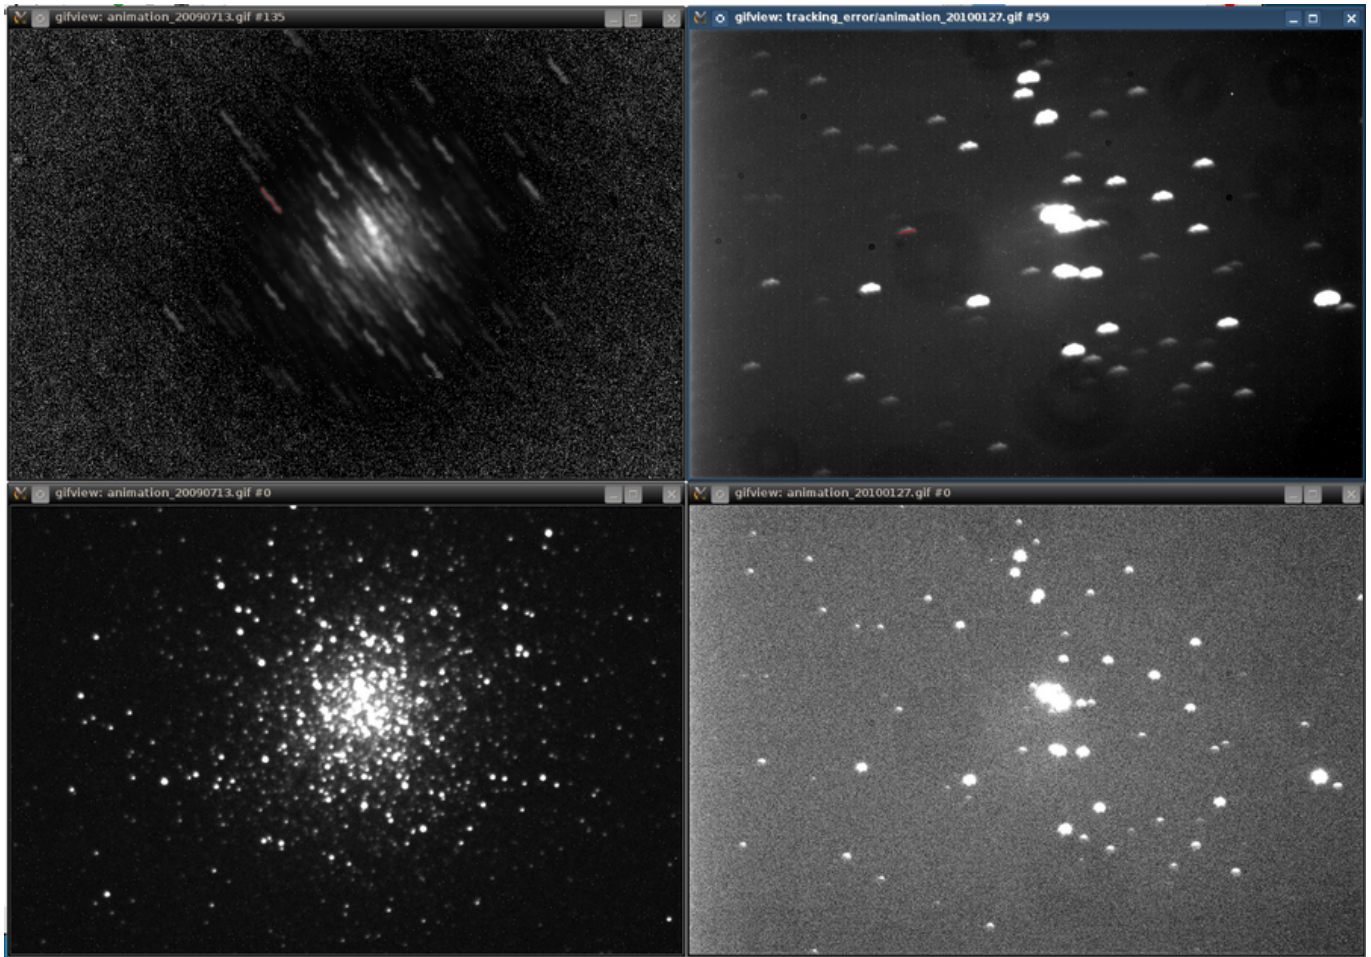
The following image illustrates the telescope's tracking problem. On the left panels, you can see the globular cluster M 13. The lower left panel shows an exposure of 10s, which gives a fair result. The upper left panel combines 135 exposures of each 10s, so approx. 35 minutes in total. The stars are clearly smeared and describe a fine zig-zag line (length of about 1/2').

The right panels show the exposures of an open cluster of 30s exposure time. Again, the lower right panel shows one exposure, the upper right the combinations of all following exposures.

Tracking errors of a globular cluster (M 13, left panels) and an open cluster (right panels)
