# Known problems, issues, and their solution

## GM4000 HPS II

<https://polaris.astro.physik.uni-potsdam.de/wiki/> - OST Wiki

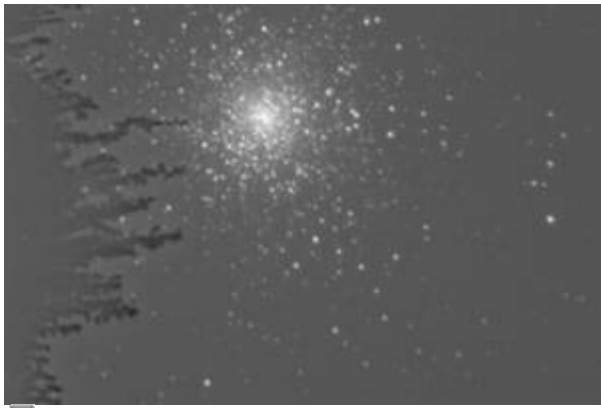
Exposure of the cluster M15 with the ST-8. The left side clearly shows icing on the CCD.

**Description of the problem:** The CCD chip of the camera has experienced icing, see image on the right.

**Solution:** The cameras' interior is not in a vacuum and moisture can get in, causing icing on the cooled CCD chip. To prevent this, the cameras have dry cartouches with desiccants. If icing appears, the cartouches need to be regenerated ([see this article](#)). During that observational night, wait for approximately one hour until the ice sublimates from the CCD chip.

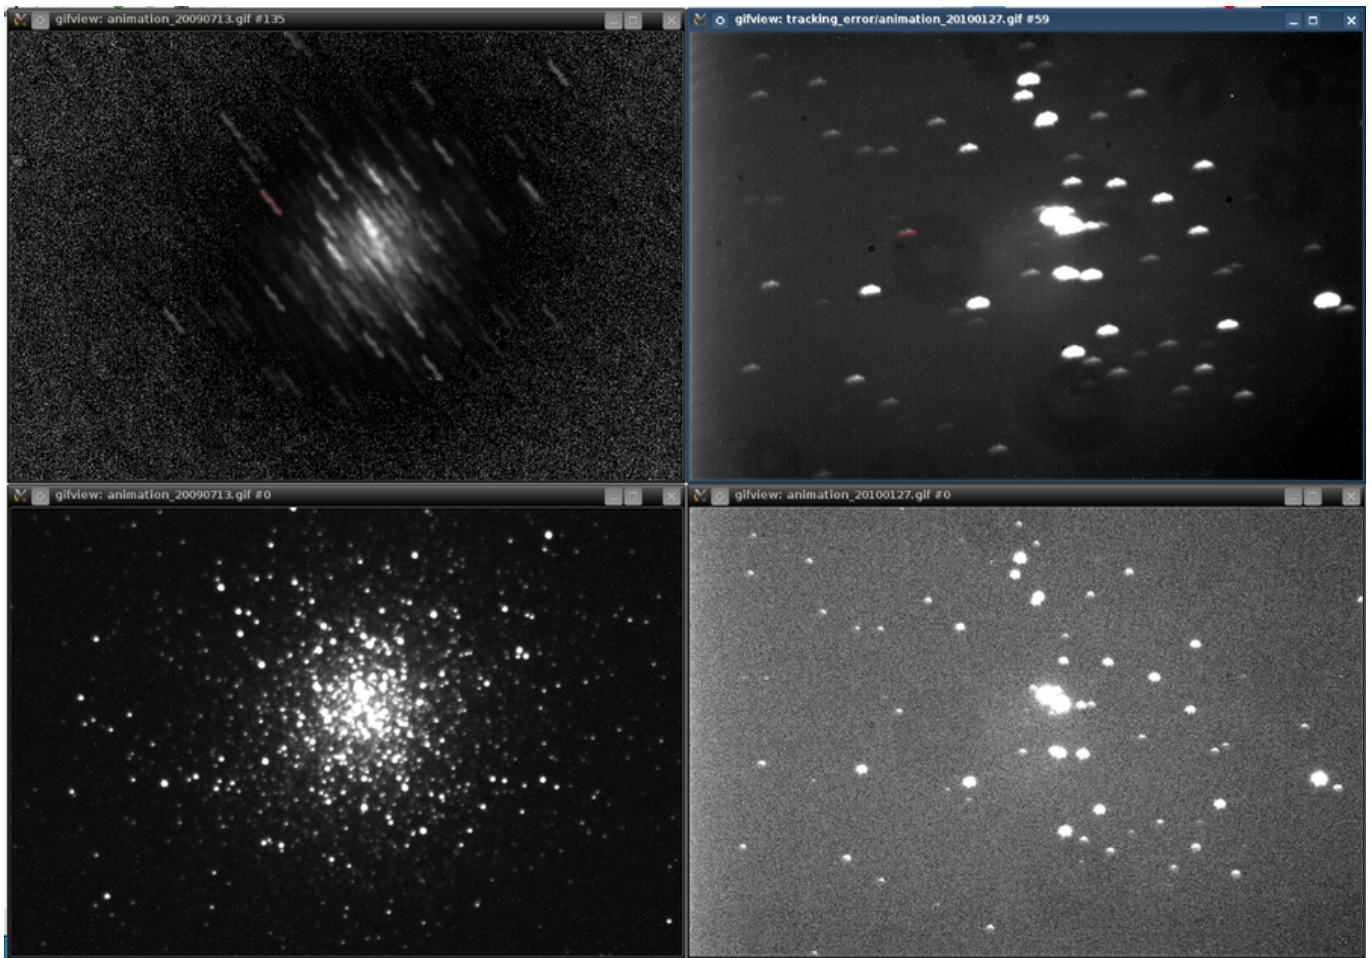
The following image illustrates the telescope's tracking problem. On the left panels, you can see the

globular cluster M 13. The lower left panel shows an exposure of 10s, which gives a fair result. The upper left panel combines 135 exposures of each 10s, so approx. 35 minutes in total. The stars are clearly smeared and describe a fine zig-zag line (length of about 1/2').

The right panels show the exposures of an open cluster of 30s exposure time. Again, the lower right panel shows one exposure, the upper right the combinations of all following exposures.

Tracking errors of a globular cluster (M 13, left panels) and an open cluster (right panels)
