Known problems, issues, and their solution

GM4000 HPS II

<https://polaris.astro.physik.uni-potsdam.de/wiki/> - OST Wiki

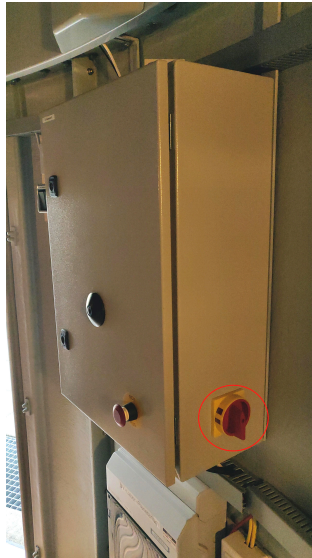
Fig. 1: Dome control box - red: main switch

Problem description: The shutter and/or hatch can no longer be moved even with the methods described above, because a component may have broken.

1. Switch off controls and power supply
 - Turn the **main switch** on the right

side of the gray dome control box to **OFF** (Fig. 1)

2. Close the hatch
 - **Move the lever** (Fig. 2) on the top of the hatch hydraulics (located to the right of the dome slit) **to the left and in a horizontal position**
 - **Close the hatch** manually by pressing from the outside
3. Close the shutter
 - **Remove the black protective cover** above the slipping clutches (red circles in Fig. 3) of the shutter drives
 - **Take the Allen wrench** (green ellipse in Fig. 3) from its holder directly next to the left-hand slipping clutch
 - **Release the slipping clutches** of the shutter drives → to do this, **loosen the Allen screws** located in a circle (Fig. 4)
 - **Insert the emergency crank** (Fig. 5, located on the left side of the dome slit) **into the socket** to the right of it (blue ellipse in Fig. 3).
 - **Crank shutter** manually

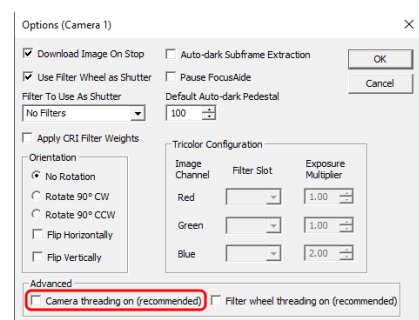
Camera options menu in *Maxim DL*

Description of the problem: When trying to couple two SBIG cameras simultaneously with *Maxim DL*, *Maxim DL* becomes very slow, hangs or crashes.

Solution: This can be due to the fact that Camera threading on (recommended) is set in the camera options. This option must be deactivated for the SBIG cameras. Afterwards the cameras should connect and work as usual.

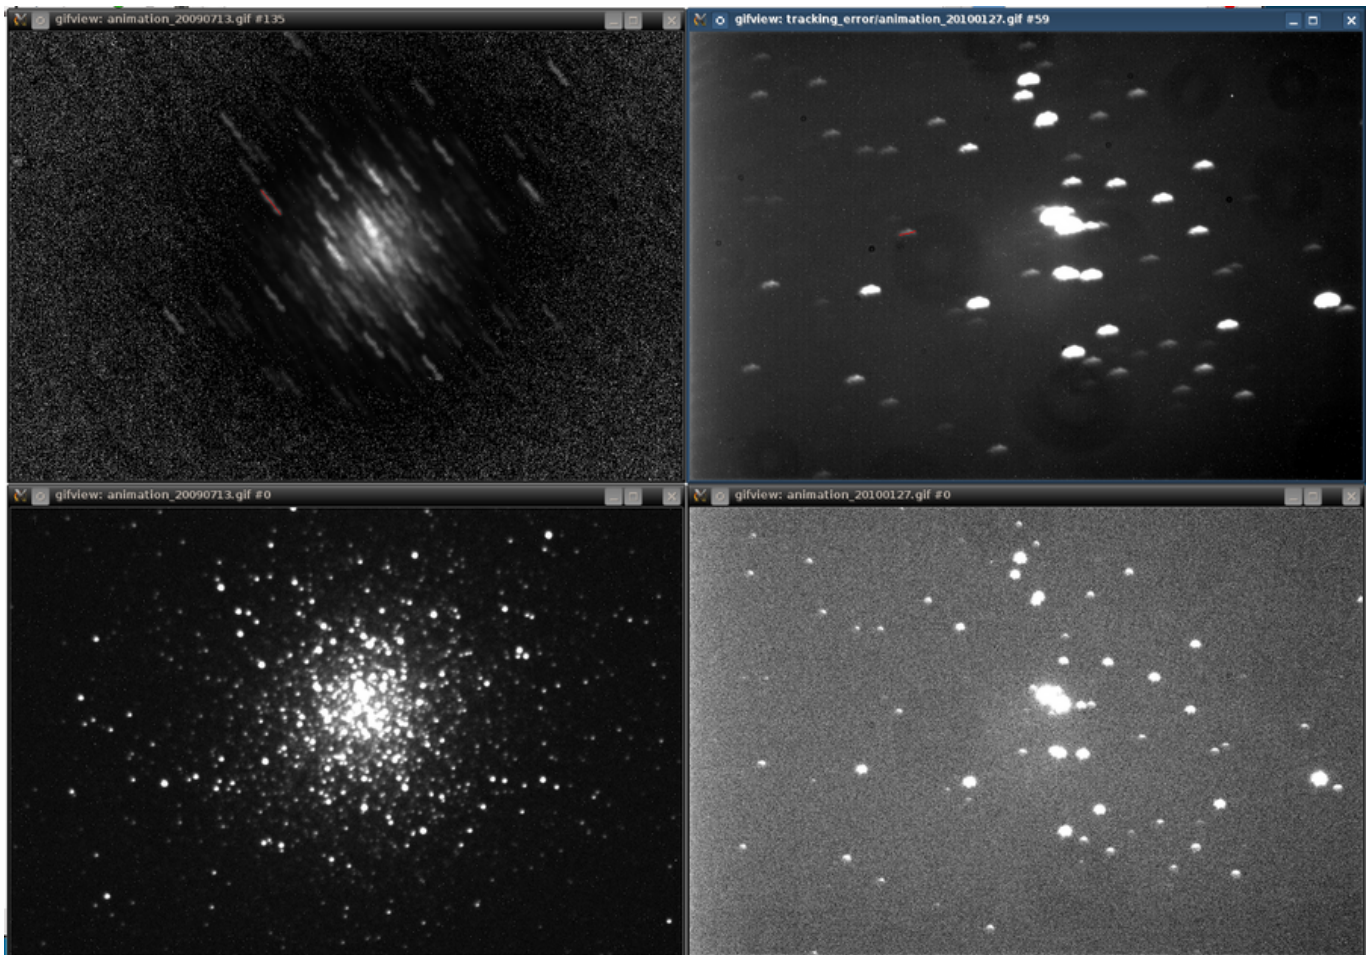
[Tracking errors of a globular cluster \(M 13, left panels\) and an open cluster \(right panels\)](#)

The following image illustrates the telescope's tracking problem. On the left panels, you can see the

globular cluster M 13. The lower left panel shows an exposure of 10s, which gives a fair result. The upper left panel combines 135 exposures of each 10s, so approx. 35 minutes in total. The stars are clearly smeared and describe a fine zig-zag line (length of about 1/2').

The right panels show the exposures of an open cluster of 30s exposure time. Again, the lower right panel shows one exposure, the upper right the combinations of all following exposures.
