# Known problems, issues, and their solution

## GM4000 HPS II

<https://polaris.astro.physik.uni-potsdam.de/wiki/> - OST Wiki

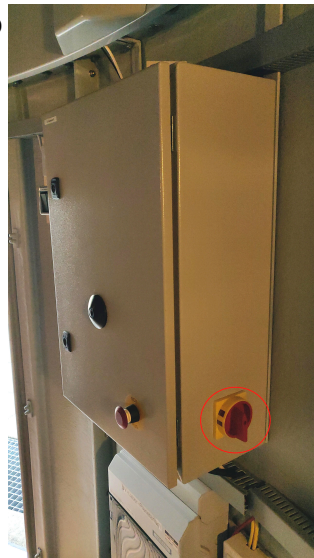
Fig. 1: Dome control box - red: main switch

**Problem description:** The shutter and/or hatch can no longer be moved even with the methods described above, because a component may have broken.

1. Switch off controls and power supply
  - Turn the **main switch** on the right

side of the gray dome control box to **OFF** (Fig. 1)

2. Close the hatch
  - **Move the lever** (Fig. 2) on the top of the hatch hydraulics (located to the right of the dome slit) **to the left and in a horizontal position**
  - **Close the hatch** manually by pressing from the outside
3. Close the shutter
  - **Remove the black protective cover** above the slipping clutches (red circles in Fig. 3) of the shutter drives
  - **Take the Allen wrench** (green ellipse in Fig. 3) from its holder directly next to the left-hand slipping clutch
  - **Release the slipping clutches** of the shutter drives → to do this, **loosen the Allen screws** located in a circle (Fig. 4)
  - **Insert the emergency crank** (Fig. 5, located on the left side of the dome slit) **into the socket** to the right of it (blue ellipse in Fig. 3).
  - **Crank shutter** manually

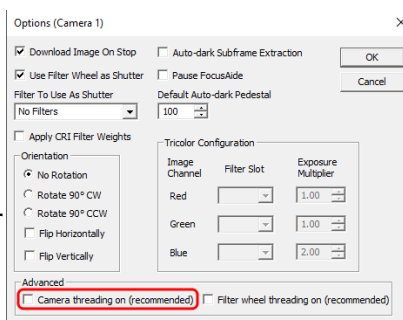
Camera options menu in *Maxim DL*

**Description of the problem:** When trying to couple two SBIG cameras simultaneously with *Maxim DL*, *Maxim DL* becomes very slow, hangs or crashes.

**Solution:** This can be due to the fact that *Camera threading on (recommended)* is set in the camera options. This option must be deactivated for the SBIG cameras. Afterwards the cameras should connect and work as usual.
