Known problems, issues, and their solution

GM4000 HPS II

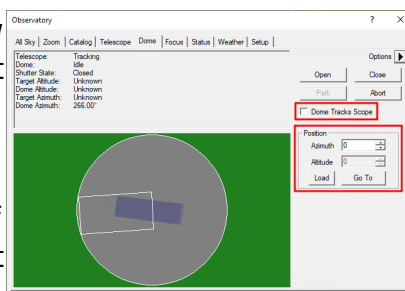
Dome wall vs. telescope I

Description of the problem: The dome's wall obscures the view of the telescope to the sky. This happens when the dome does not follow the pointing of the telescope, i.e. the open shutter is not in phase with the telescope.

Solution: The dome control can determine the current position of the dome by means of a magnet. For this purpose, the dome must be moved through the south point once:

1. Disconnect the dome from the telescope. To do this, go to the **Dome tab** in *Maxim DL* in the **Observatory control window** and deactivate the option **Dome Tracks Scope**.
2. Then the dome can be moved around using the dome remote control or in *Maxim DL* in the **Dome tab** of the **Observatory control window** using the options in the **Positions** section. For the latter, the desired target azimuth (Azimuth) must be selected and then **Go To** clicked.
3. Finally, re-establish the connection between the dome and the telescope.

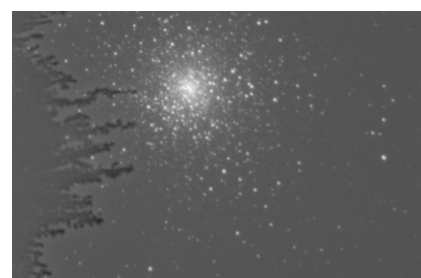
Ice on the camera

Description of the problem: The CCD chip of the camera has experienced icing, see image on the right.

Solution: The cameras' interior is not in a vacuum and moisture

can get in, causing icing on the cooled CCD chip. To prevent this, the cameras have dry cartouches with desiccants. If icing appears, the cartouches need to be regenerated ([see this article](#)). During that observational night, wait for approximately one hour until the ice sublimates from the CCD chip.

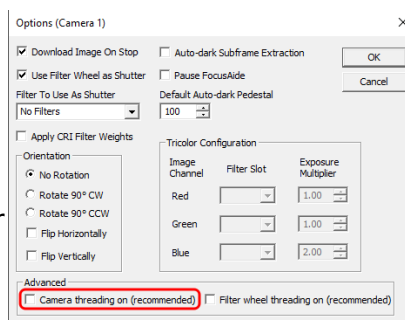
Camera options menu in *Maxim DL*

Description of the problem: When trying to couple two SBIG cameras simultaneously with *Maxim DL*, *Maxim DL* becomes very slow, hangs or crashes.

Solution: This can be due to the fact that *Camera threading on (recommended)* is set in the camera options. This option must be deactivated for the SBIG cameras. Afterwards the cameras should connect and work as usual.

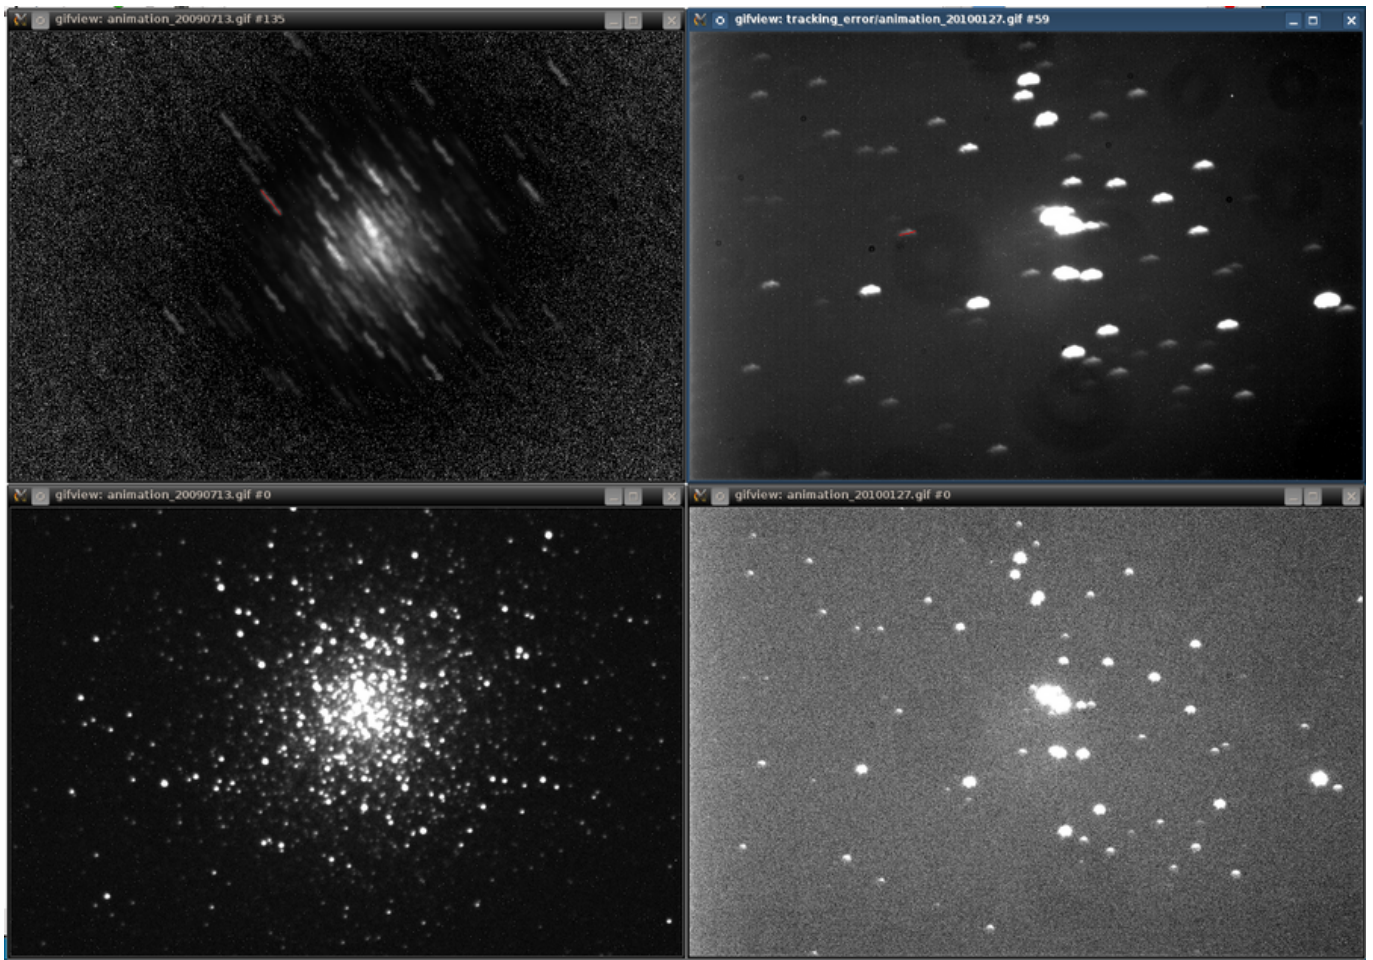
The following image illustrates the telescope's tracking problem. On the left panels, you can see the globular cluster M 13. The lower left panel shows an exposure of 10s, which gives a fair result. The upper left panel combines 135 exposures of each 10s, so approx. 35 minutes in total. The stars are clearly smeared and describe a fine zig-zag line (length of about 1/2').

The right panels show the exposures of an open cluster of 30s exposure time. Again, the lower right panel shows one exposure, the upper right the combinations of all following exposures.

Tracking errors of a globular cluster (M 13, left panels) and an open cluster (right panels)
