Known problems, issues, and their solution

GM4000 HPS II

<https://polaris.astro.physik.uni-potsdam.de/wiki/> - OST Wiki

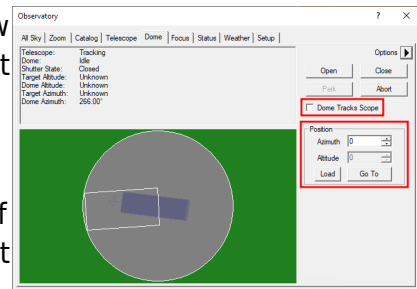
Dome wall vs. telescope I

Description of the problem: The dome's wall obscures the view of the telescope to the sky. This happens when the dome does not follow the pointing of the telescope, i.e. the open shutter is not in phase with the telescope.

Solution: The dome control can determine the current position of the dome by means of a magnet. For this purpose, the dome must be moved through the south point once:

1. Disconnect the dome from the telescope. To do this, go to the **Dome tab** in *Maxim DL* in the **Observatory control window** and deactivate the option Dome Tracks Scope.
2. Then the dome can be moved around using the dome remote control or in *Maxim DL* in the **Dome tab** of the **Observatory control window** using the options in the Positions section. For the latter, the desired target azimuth (Azimuth) must be selected and then Go To clicked.
3. Finally, re-establish the connection between the dome and the telescope.

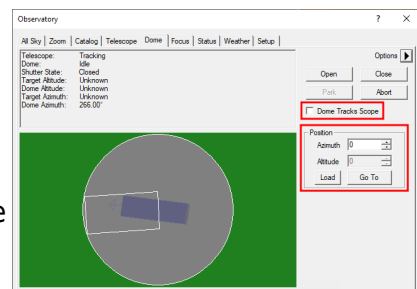
Dome wall vs. telescope II

Description of the problem: The motor that drives the dome rotation can be heard but the dome does not rotate.

1. Push in the red emergency switch on the control unit for the dome (see [here](#)).
2. Disconnect the dome from the telescope. To do this, go to the **Dome tab** in *Maxim DL* in the **Observatory control window** and deactivate the option Dome Tracks Scope.
3. Pull out the emergency switch again. The dome can now be operated again using the remote control.
4. Now press the azimuth buttons alternately until the dome moves freely again.
5. Finally, re-establish the connection between the dome and the telescope.

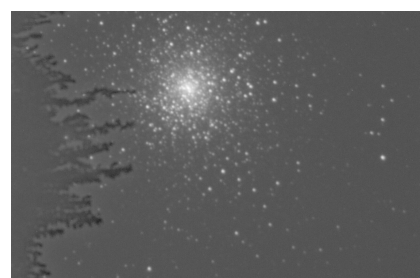
Description of the problem: The CCD chip of the camera has experienced icing, see image on the right.

Solution: The cameras' interior is not in a vacuum and moisture

can get in, causing icing on the cooled CCD chip. To prevent this, the cameras have dry cartouches with desiccants. If icing appears, the cartouches need to be regenerated ([see this article](#)). During that observational night, wait for approximately one hour until the ice sublimates from the CCD chip.

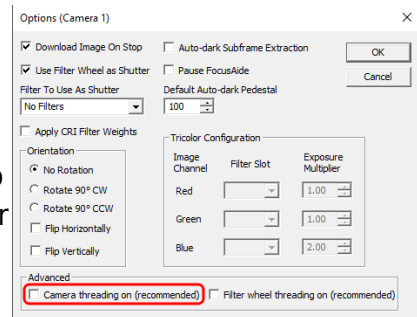
Camera options menu in *Maxim DL*

Description of the problem: When trying to couple two SBIG cameras simultaneously with *Maxim DL*, *Maxim DL* becomes very slow, hangs or crashes.

Solution: This can be due to the fact that Camera threading on (recommended) is set in the camera options. This option must be deactivated for the SBIG cameras. Afterwards the cameras should connect and work as usual.

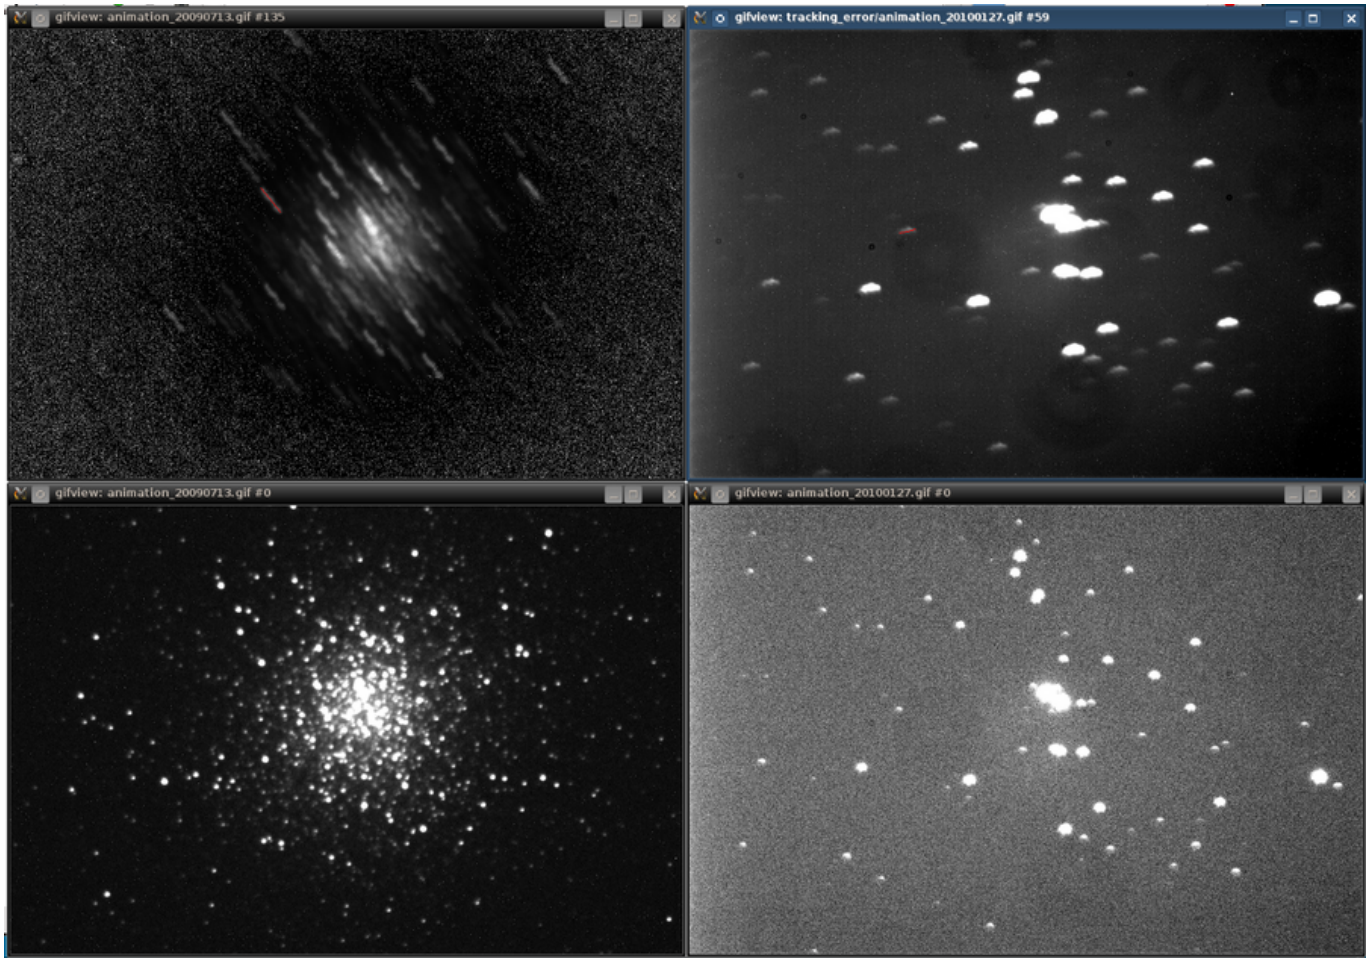
The following image illustrates the telescope's tracking problem. On the left panels, you can see the globular cluster M 13. The lower left panel shows an exposure of 10s, which gives a fair result. The upper left panel combines 135 exposures of each 10s, so approx. 35 minutes in total. The stars are clearly smeared and describe a fine zig-zag line (length of about 1/2').

The right panels show the exposures of an open cluster of 30s exposure time. Again, the lower right panel shows one exposure, the upper right the combinations of all following exposures.

Tracking errors of a globular cluster (M 13, left panels) and an open cluster (right panels)
