# Known problems, issues, and their solution

## GM4000 HPS II

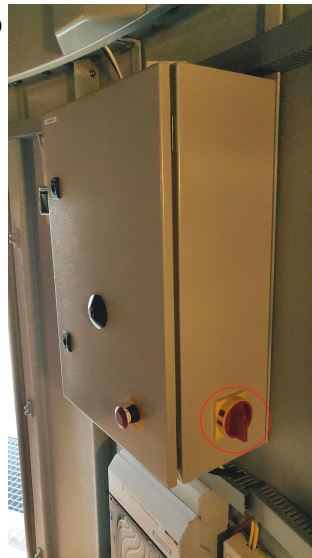
**Problem description:** The shutter and/or hatch can no longer be moved even with the methods described above, because a component may have broken.

Fig. 3: Shutter mechanism - red: slipping clutches, green: Allen wrench, blue: socket for the

Fig. 1: Dome control box - red: main switch

Fig. 2: Hatch hydraulics - red: lever for switching it off

1. Switch off controls and power supply
  - Turn the **main switch** on the right

- side of the gray dome control box **to OFF** (Fig. 1)
2. Close the hatch
    - **Move the lever** (Fig. 2) on the top of the hatch hydraulics (located to the right of the dome slit) **to the left and in a horizontal position**
    - **Close the hatch** manually by pressing from the outside
  3. Close the shutter
    - **Remove the black protective cover** above the slipping clutches (red circles in Fig. 3) of the shutter drives
    - **Take the Allen wrench** (green ellipse in Fig. 3) from its holder directly next to the left-hand slipping clutch
    - **Release the slipping clutches** of the shutter drives → to do this, **loosen the Allen screws** located in a circle (Fig. 4)
    - **Insert the emergency crank** (Fig. 5, located on the left side of the dome slit) **into the socket** to the right of it (blue ellipse in Fig. 3).
    - **Crank shutter** manually
