Known problems, issues, and their solution

GM4000 HPS II

<https://polaris.astro.physik.uni-potsdam.de/wiki/> - OST Wiki

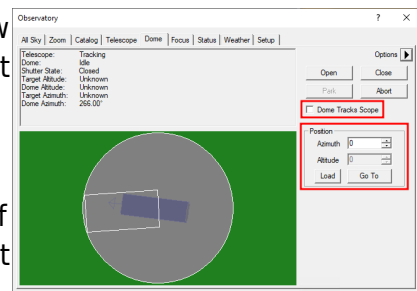
Description of the problem: The dome's wall obscures the view of the telescope to the sky. This happens when the dome does not follow the pointing of the telescope, i.e. the open shutter is not in phase with the telescope.

Solution: The dome control can determine the current position of the dome by means of a magnet. For this purpose, the dome must be moved through the south point once:

1. Disconnect the dome from the telescope. To do this, go to the **Dome tab** in *Maxim DL* in the **Observatory control window** and deactivate the option **Dome Tracks Scope**.
2. Then the dome can be moved around using the dome remote control or in *Maxim DL* in the **Dome tab** of the **Observatory control window** using the options in the **Positions** section. For the latter, the desired target azimuth (Azimuth) must be selected and then **Go To** clicked.
3. Finally, re-establish the connection between the dome and the telescope.

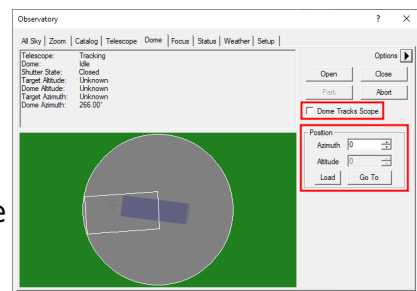
Description of the problem: The motor that drives the dome rotation can be heard but the dome does not rotate.

1. Push in the red emergency switch on the control unit for the dome (see [here](#)).
2. Disconnect the dome from the telescope. To do this, go to the **Dome tab** in *Maxim DL* in the **Observatory control window** and deactivate the option **Dome Tracks Scope**.
3. Pull out the emergency switch again. The dome can now be operated again using the remote control.
4. Now press the azimuth buttons alternately until the dome moves freely again.
5. Finally, re-establish the connection between the dome and the telescope.

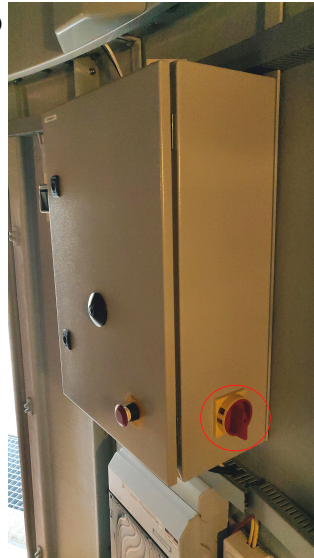
Fig. 1: Dome control box - red: main switch

Problem description: The shutter and/or hatch can no longer be moved even with the methods described above, because a component may have broken.

1. Switch off controls and power supply
 - Turn the **main switch** on the right

- side of the gray dome control box **to OFF** (Fig. 1)
2. Close the hatch
 - **Move the lever** (Fig. 2) on the top of the hatch hydraulics (located to the right of the dome slit) **to the left and in a horizontal position**
 - **Close the hatch** manually by pressing from the outside
 3. Close the shutter
 - **Remove the black protective cover** above the slipping clutches (red circles in Fig. 3) of the shutter drives
 - **Take the Allen wrench** (green ellipse in Fig. 3) from its holder directly next to the left-hand slipping clutch
 - **Release the slipping clutches** of the shutter drives → to do this, **loosen the Allen screws** located in a circle (Fig. 4)
 - **Insert the emergency crank** (Fig. 5, located on the left side of the dome slit) **into the socket** to the right of it (blue ellipse in Fig. 3).
 - **Crank shutter** manually

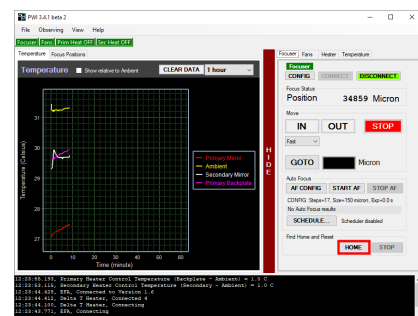
Problem description: PWI3 shows clearly negative position values when driving in or the focuser does not run in the positive range (when driving out) up to the maximum ~35000µ.

Solution: The focuser has “swallowed” and the encoder delivers wrong values. This can be fixed by clicking on Home (see picture) in the Focuser tab of PWI3 under Find Home and Reset and then on YES. This will reset the focuser and reinitialize the home position, restoring the normal focus range.

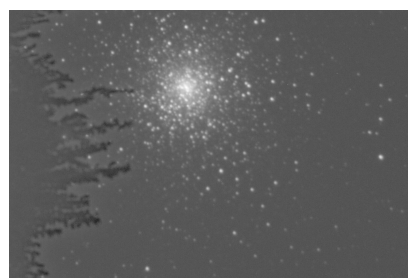
Description of the problem: The CCD chip of the camera has experienced icing, see image on the right.

Exposure of the cluster M15 with the ST-8. The left side clearly shows icing on the CCD.

Solution: The cameras' interior is not in a vacuum and moisture can get in, causing icing on the cooled CCD chip. To prevent this, the cameras have dry cartouches with desiccants. If icing appears, the cartouches need to be regenerated ([see this article](#)). During that observational night, wait for approximately one hour until the ice sublimates from the CCD chip.
