Known problems, issues, and their solution

GM4000 HPS II

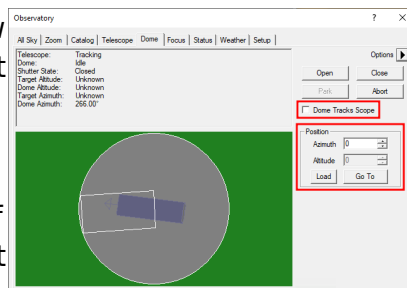
Description of the problem: The dome's wall obscures the view of the telescope to the sky. This happens when the dome does not follow the pointing of the telescope, i.e. the open shutter is not in phase with the telescope.

Solution: The dome control can determine the current position of the dome by means of a magnet. For this purpose, the dome must be moved through the south point once:

1. Disconnect the dome from the telescope. To do this, go to the **Dome tab** in *Maxim DL* in the **Observatory control window** and deactivate the option Dome Tracks Scope.
2. Then the dome can be moved around using the dome remote control or in *Maxim DL* in the **Dome tab** of the **Observatory control window** using the options in the Positions section. For the latter, the desired target azimuth (Azimuth) must be selected and then Go To clicked.
3. Finally, re-establish the connection between the dome and the telescope.

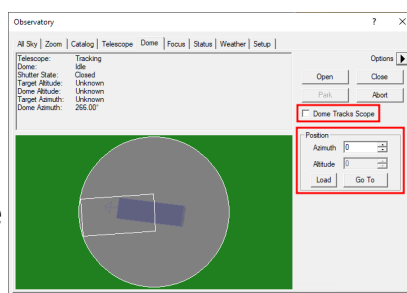
Description of the problem: The motor that drives the dome rotation can be heard but the dome does not rotate.

1. Push in the red emergency switch on the control unit for the dome (see [here](#)).
2. Disconnect the dome from the telescope. To do this, go to the **Dome tab** in *Maxim DL* in the **Observatory control window** and deactivate the option Dome Tracks Scope.
3. Pull out the emergency switch again. The dome can now be operated again using the remote control.
4. Now press the azimuth buttons alternately until the dome moves freely again.
5. Finally, re-establish the connection between the dome and the telescope.

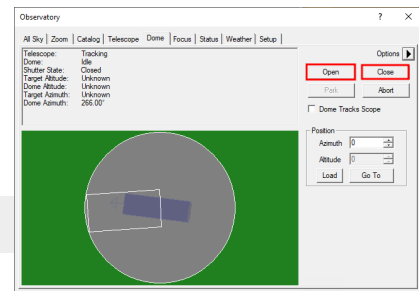
Description of the problem: The shutter or the hatch do not close via the remote control.

Solution 1: On the hand terminal, use the command to close the dome completely:

MENU - Settings - Dome - Close Shutter

. After that, the hatch and shutter should open and close properly again using the remote control.

Solution 2: In *Maxim DL* in the **Observatory control window** go to the **Dome-Tab** and try to open the dome again with Open. Afterwards close it with Close.

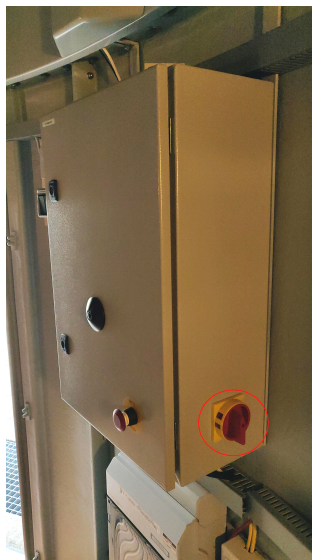
Fig. 1: Dome control box - red: main switch

Problem description: The shutter and/or hatch can no longer be moved even with the methods described above, because a component may have broken.

1. Switch off controls and power supply
 - Turn the **main switch** on the right

side of the gray dome control box **to OFF** (Fig. 1)

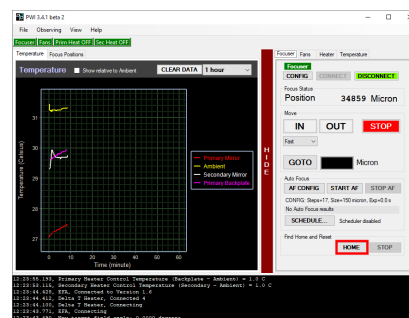
Problem description: PWI3 shows clearly negative position values when driving in or the focuser does not run in the positive range (when driving out) up to the maximum ~35000μ.

Solution: The focuser has “swallowed” and the encoder delivers wrong values. This can be fixed by clicking on Home (see picture) in the Focuser tab of PWI3 under Find Home and Reset and then on YES. This will reset the focuser and reinitialize the home position, restoring the normal focus range.

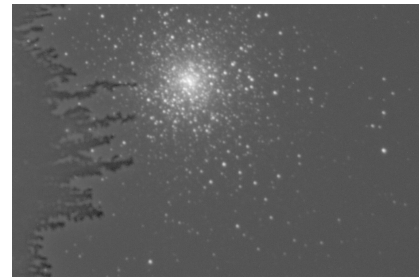
Description of the problem: The CCD chip of the camera has experienced icing, see image on the right.

Exposure of the cluster M15 with the ST-8. The left side clearly shows icing on the CCD.

Solution: The cameras' interior is not in a vacuum and moisture can get in, causing icing on the cooled CCD chip. To prevent this, the cameras have dry cartouches with desiccants. If icing appears, the cartouches need to be regenerated ([see this article](#)). During that observational night, wait for approximately one hour until the ice sublimates from the CCD chip.

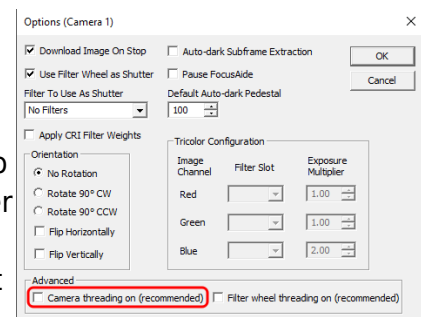
Camera options menu in *Maxim DL*

Description of the problem: When trying to couple two SBIG cameras simultaneously with *Maxim DL*, *Maxim DL* becomes very slow, hangs or crashes.

Solution: This can be due to the fact that Camera threading on (recommended) is set in the camera options. This option must be deactivated for the SBIG cameras. Afterwards the cameras should connect and work as usual.

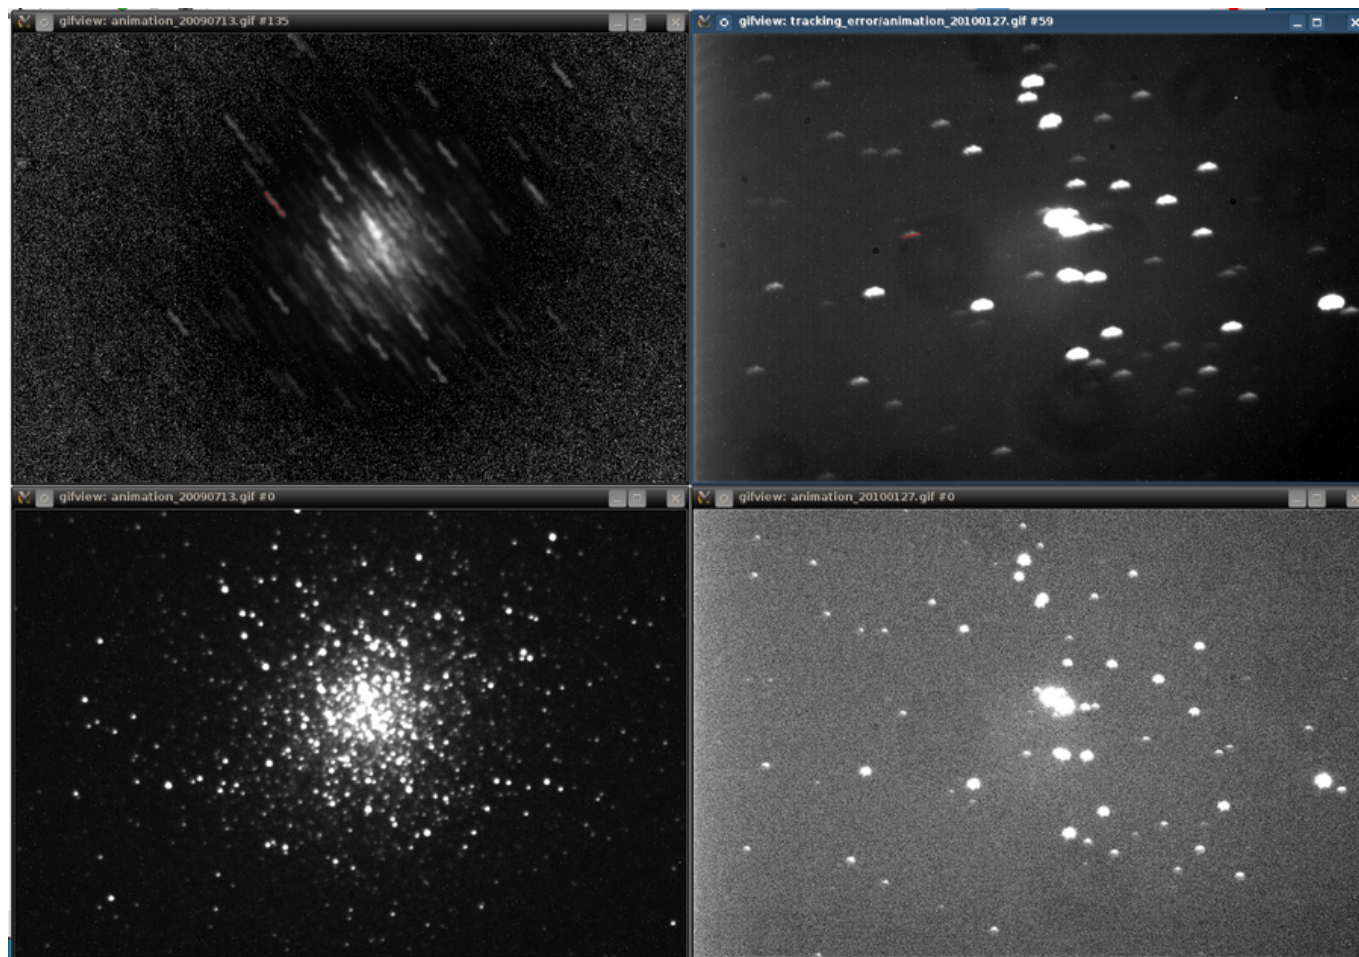
The following image illustrates the telescope's tracking problem. On the left panels, you can see the globular cluster M 13. The lower left panel shows an exposure of 10s, which gives a fair result. The upper left panel combines 135 exposures of each 10s, so approx. 35 minutes in total. The stars are clearly smeared and describe a fine zig-zag line (length of about 1/2').

The right panels show the exposures of an open cluster of 30s exposure time. Again, the lower right panel shows one exposure, the upper right the combinations of all following exposures.

Tracking errors of a globular cluster (M 13, left panels) and an open cluster (right panels)
