Known problems, issues, and their solution

<https://polaris.astro.physik.uni-potsdam.de/wiki/> - **OST Wiki**

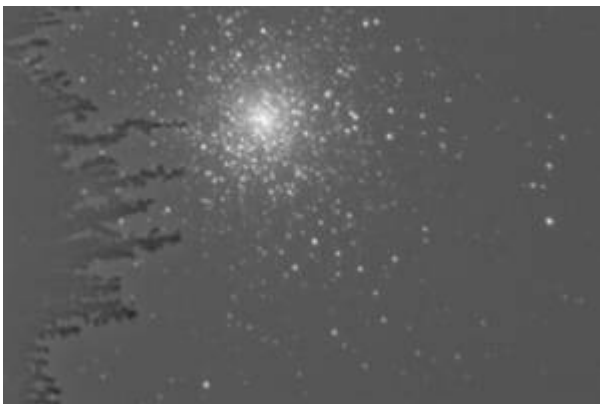
Ice on the camera

Exposure of the cluster M15 with the ST-8. The left side clearly shows icing on the CCD.

Description of the problem: The CCD chip of the camera has experienced icing, see image on the right.

Solution: The cameras' interior is not in a vacuum and moisture can get in, causing icing on the cooled CCD chip. To prevent this, the cameras have dry cartouches with desiccants. If icing appears, the cartouches need to be regenerated ([see this article](#)). During that observational night, wait for approximately one hour until the ice sublimates from the CCD chip.

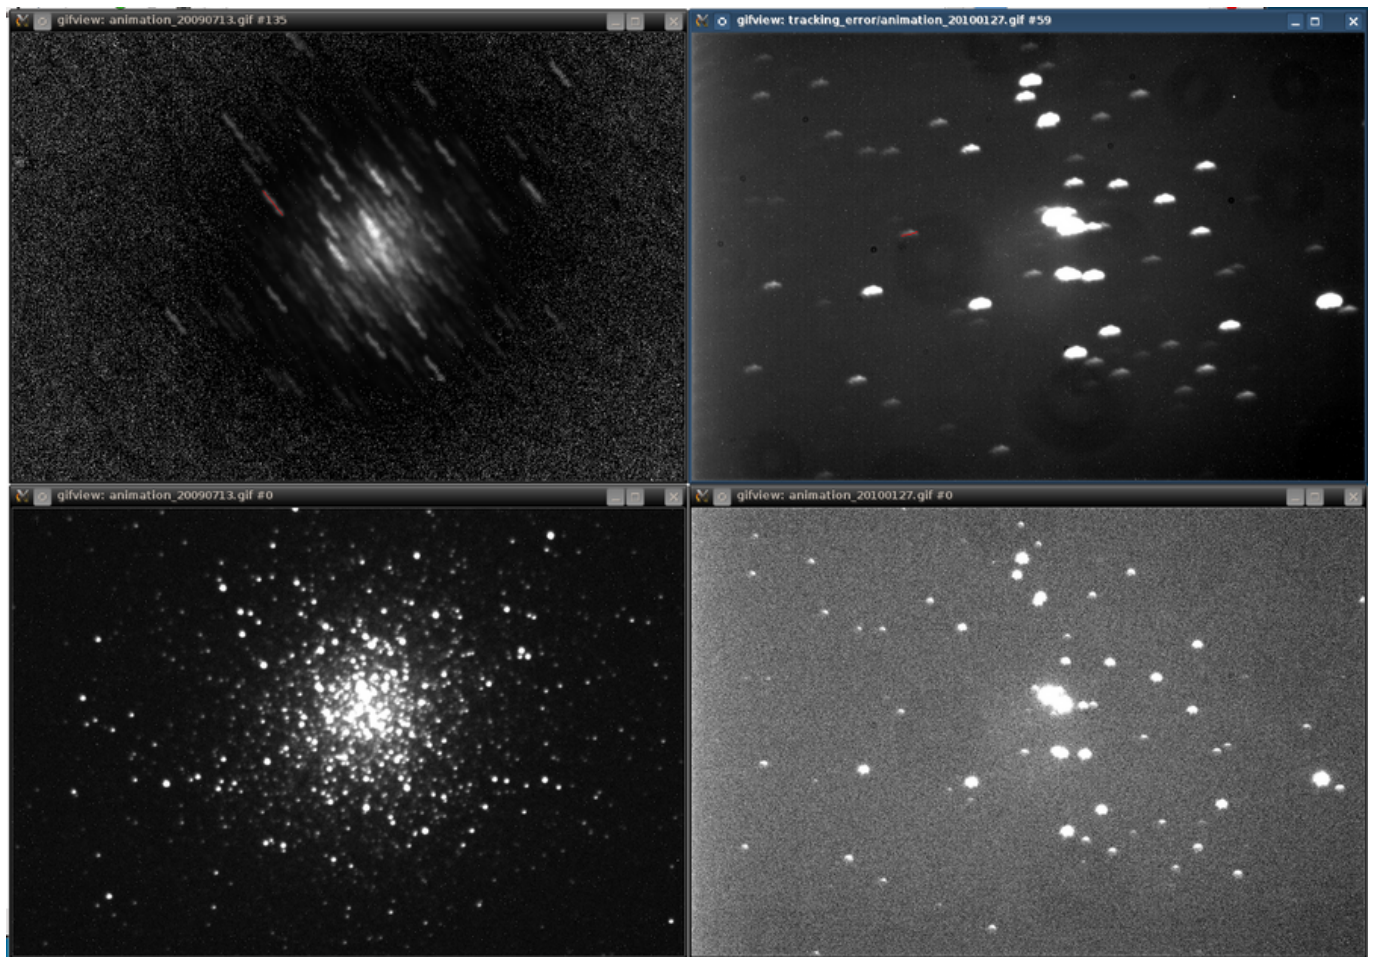
Tracking error

The following image illustrates the telescope's tracking problem. On the left panels, you can see the globular cluster M 13. The lower left panel shows an exposure of 10s, which gives a fair result. The upper left panel combines 135 exposures of each 10s, so approx. 35 minutes in total. The stars are clearly smeared and describe a fine zig-zag line (length of about $1/2'$).

The right panels show the exposures of an open cluster of 30s exposure time. Again, the lower right panel shows one exposure, the upper right the combinations of all following exposures.

Tracking errors of a globular cluster (M 13, left panels) and an open cluster (right panels)
