# Known problems, issues, and their solution

## GM4000 HPS II

<https://polaris.astro.physik.uni-potsdam.de/wiki/> - OST Wiki

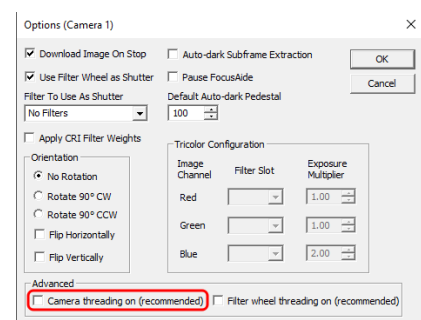
**Description of the problem:** When trying to couple two SBIG cameras simultaneously with *Maxim DL*, *Maxim DL* becomes very slow, hangs or crashes.

Camera options menu in *Maxim DL*

**Solution:** This can be due to the fact that Camera threading on (recommended) is set in the camera options. This option must be deactivated for the SBIG cameras. Afterwards the cameras should connect and work as usual.
